Gordon Playground
Inspections LTD **PSSLive+**

Operational Inspection – December 2020

Churchdown Parish Council

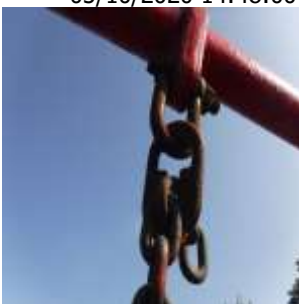
Asset Name	Finding Title	Finding Creation	Resolve By Date	Risk Level	Risk Value	Standard Ref	Cause
2 Bay 4 Flat Seat Swing	Chain - Cruxiform Connector(s) Worn - (previously reported)	21/09/2020	23/03/2021	Very Low	1 x 3 = 3		Wear and Tear

Task Title
Replace cruxiform connector(s)

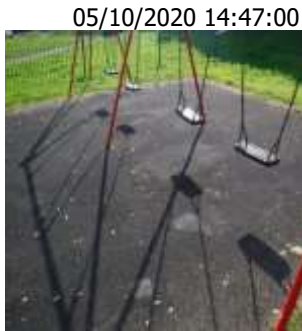
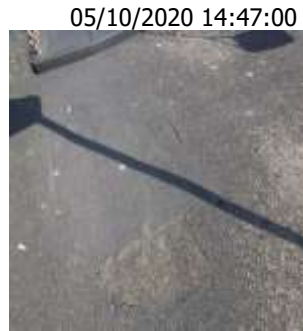
Standard Description: Surface wearing

Task Title
Monitor

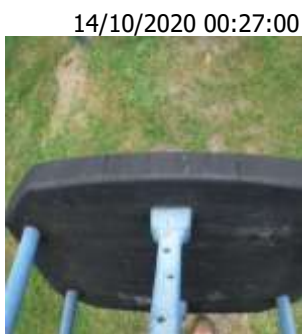
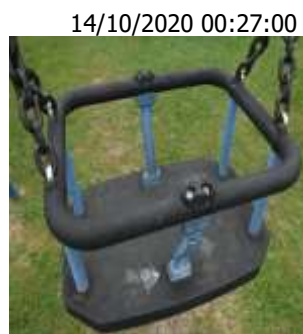
Standard Description: The rubber is deteriorating/degrading

Task Title

Monitor

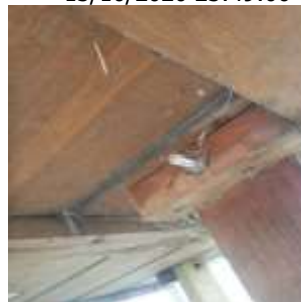
Asset Name	Finding Title	Finding Creation	Resolve By Date	Risk Level	Risk Value	Standard Ref	Cause
Picnic Table (Timber) x2	Finish - Bolts Protruding - (previously reported)	21/09/2020	22/12/2020	Low	2 x 2 = 4	EN 1176:2017 - 1 - 4.2.5	Installation Defect

Task Title
Remove excessive threads

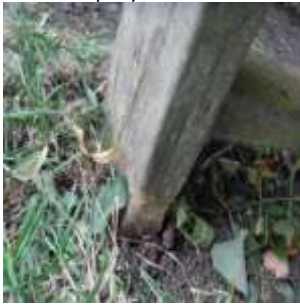
Asset Name	Finding Title	Finding Creation	Resolve By Date	Risk Level	Risk Value	Standard Ref	Cause
Picnic Table (Timber) x2	Timber - Strimmer Damage - (previously reported)	21/09/2020	23/03/2021	Very Low	1 x 1 = 1		Poor Maintenance

Task Title
Notify grounds maintenance staff

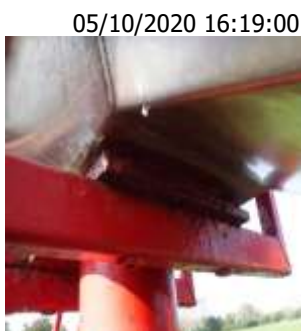
Standard Description: Metal excessive corrosion

Task Title

Monitor

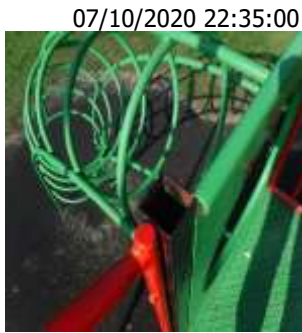
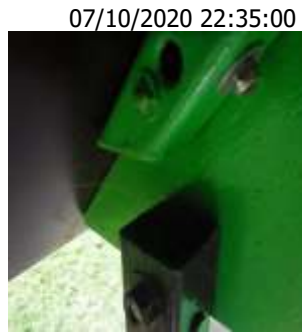
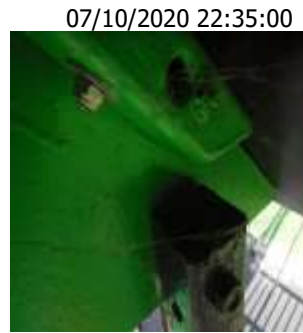
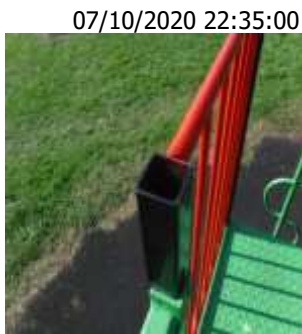
Standard Description: Cap(s) missing

Task Title
Replace

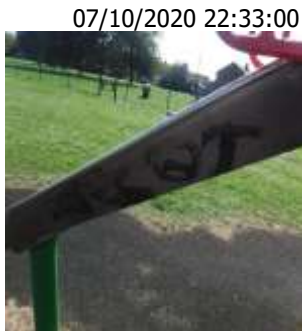
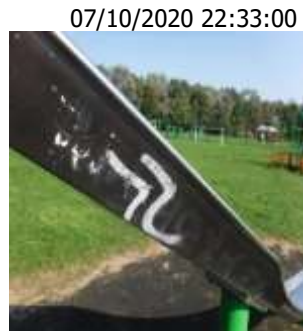
Asset Name	Finding Title	Finding Creation	Resolve By Date	Risk Level	Risk Value	Standard Ref	Cause
Junior Multiplay	Item - Graffiti - Present - (previously reported)	21/09/2020	23/03/2021	Very Low	1 x 1 = 1		Vandalism

Standard Description: Graffiti present

Task Title
Remove graffiti

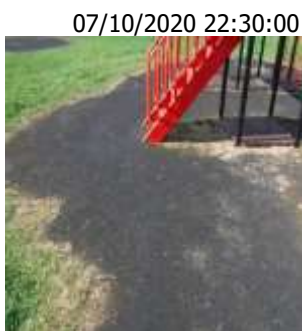
Standard Description: Surface wearing

Task Title

Monitor
