D E Spencer & Sons UK Ltd
Nupend
Stonehouse
Gloucestershire
GL10 3SS
01453 822764
12 October 2020

RE: Churchdown Parish Council. Churchdown Recreation Park, Ponds Survey

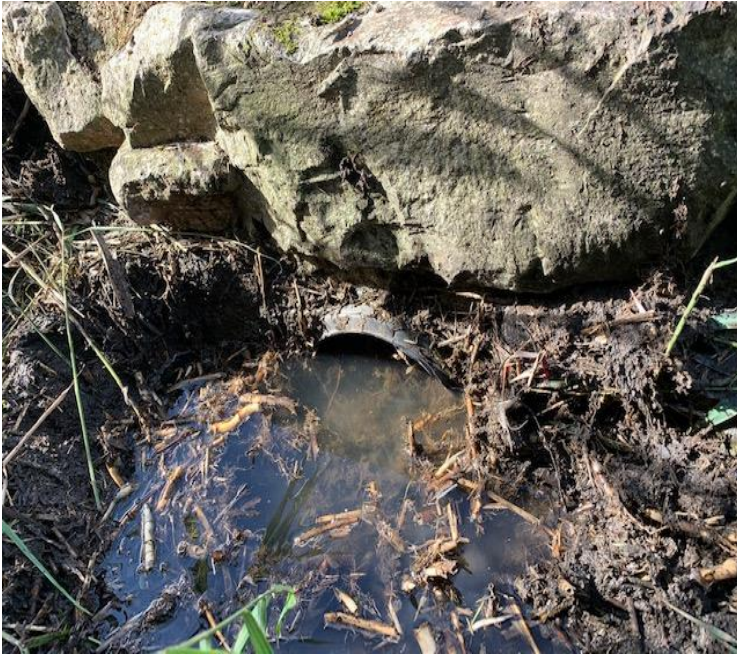
Most of the ponds are working well with water levels at the designed level, the only one being slightly high is reed bed A, which has a water level 125mm higher than the design level, the inlet pipe should be running clear but is 70% submerged.

Photo shows 225mm pipe supplying Reed Bed A, from the nearby manhole, this pipe should be running clear and is about 70% submerged.

This should be easily rectified by clearing around the outlet pipe, which is about 500mm below water level and connects at a low level to pond A.

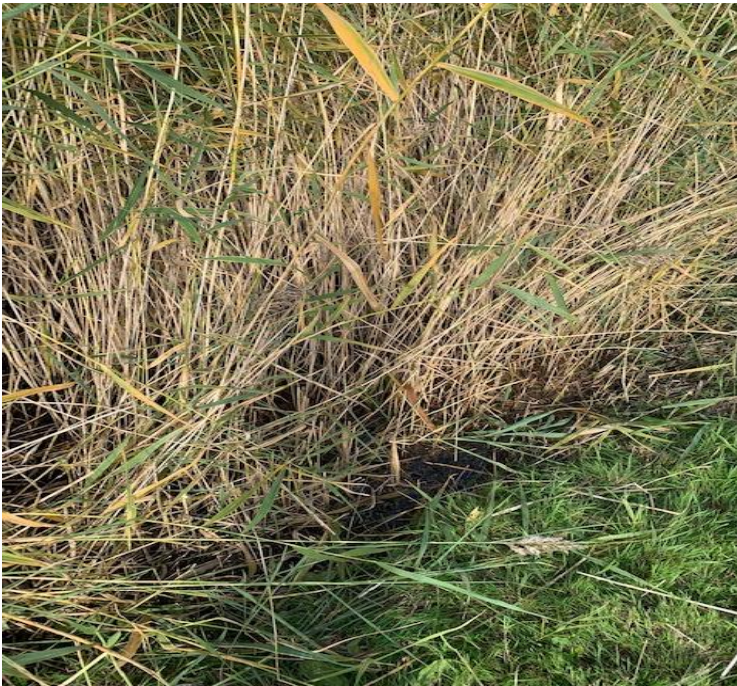
Location of pipe from Reed Bed A, pipe is around 500mm below water level and is surrounded with a filter media. Cleaning or replacing some of the media should reduce the water level so that the inlet pipe is clear.

Water is passing through all of the ponds and outletting into the watercourse at the main outfall. I would not recommend carrying out any maintenance work at this stage, other than possibly more clearing around pipework to improve flow and reduce chances of blockages and, attempt to reduce the water level in reed bed A, by excavating down to the outlet pipe and cleaning or replacing some of the filter media surrounding the pipe.

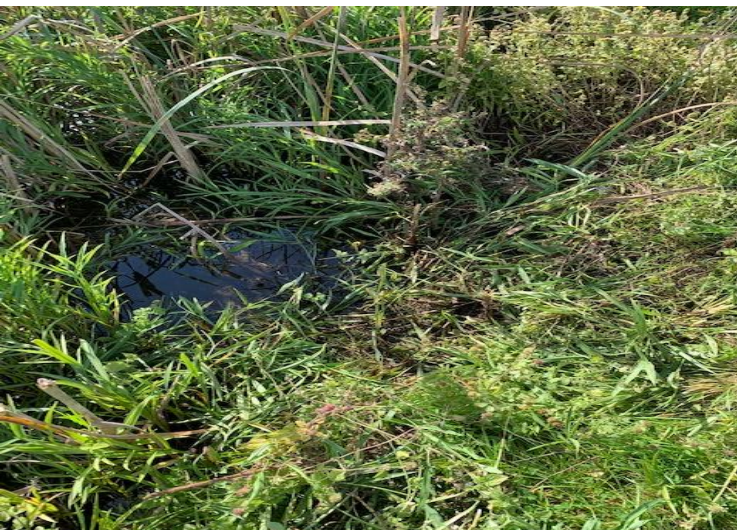
Photo shows location of pipe into Pond A, low level connecting pipe

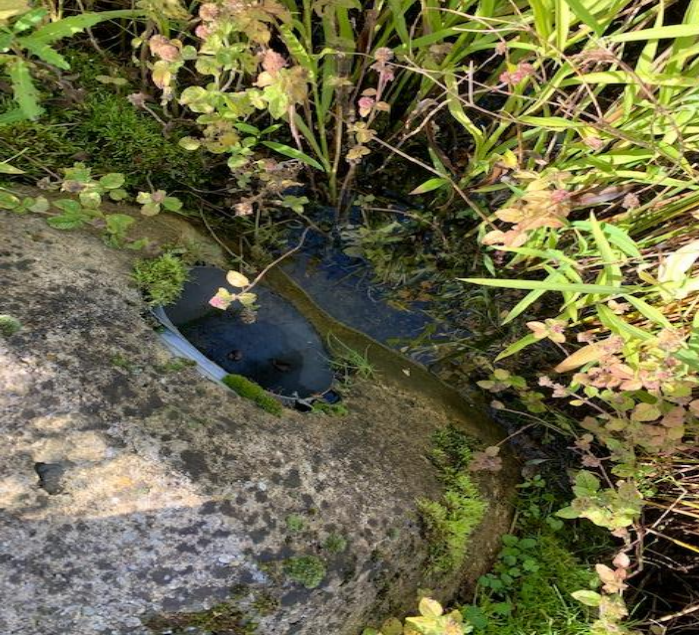
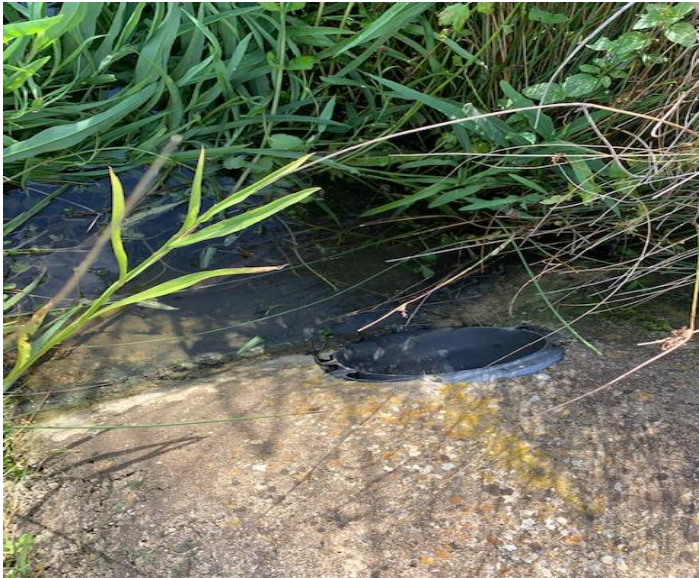
Outlet pipe from Pond A, high level, this pipe sets the water level in Pond A.

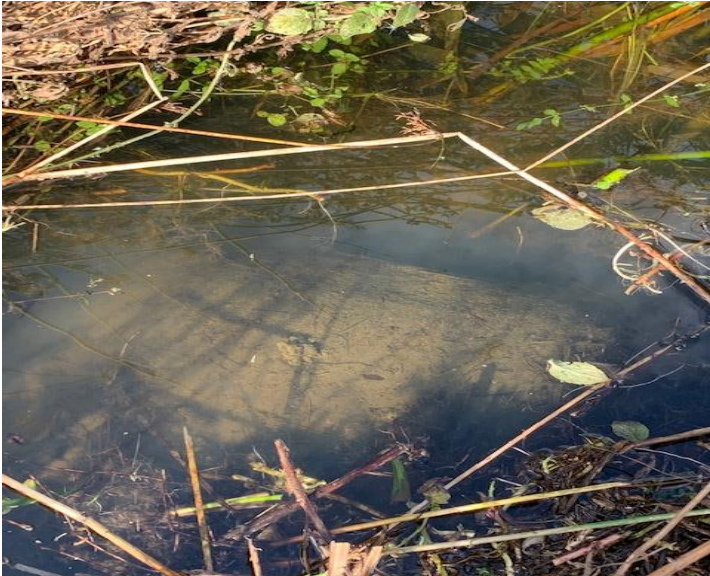
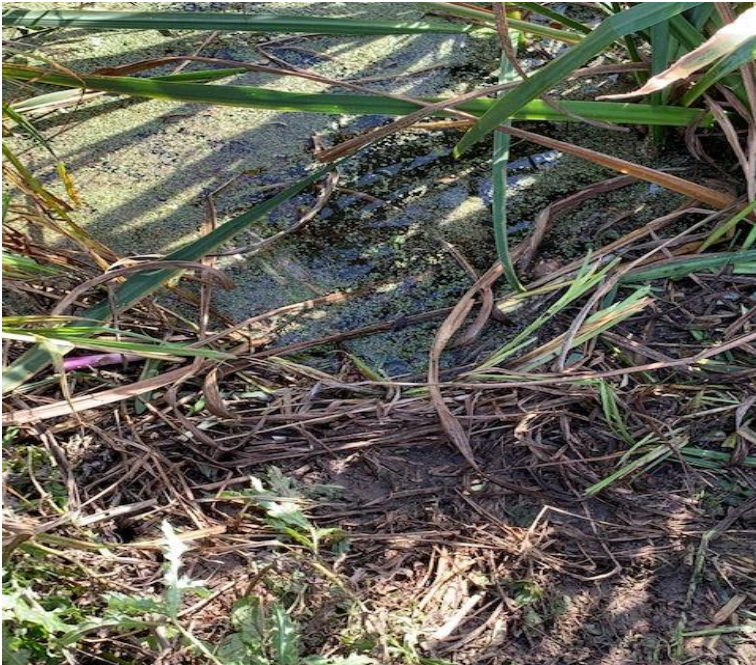
Inlet pipe to Pond B, high level, running clear, bottom photo shows the outlet pipe from Pond B, low level, just visible below water level.

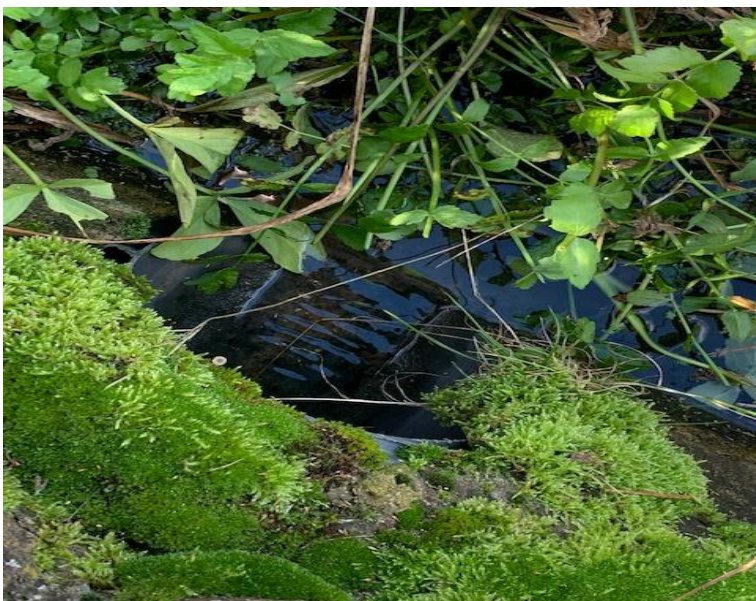
Location of inlet pipe to Pond C,
low level connection

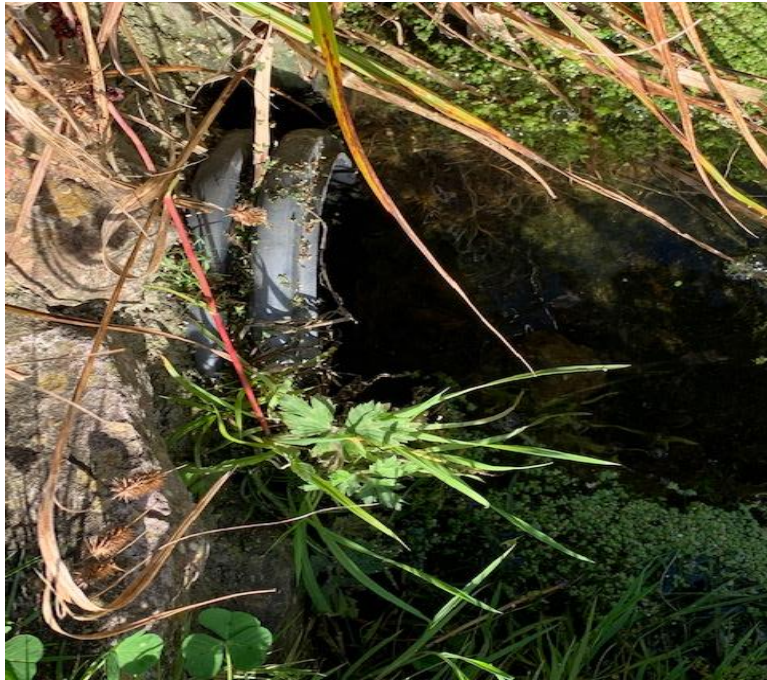
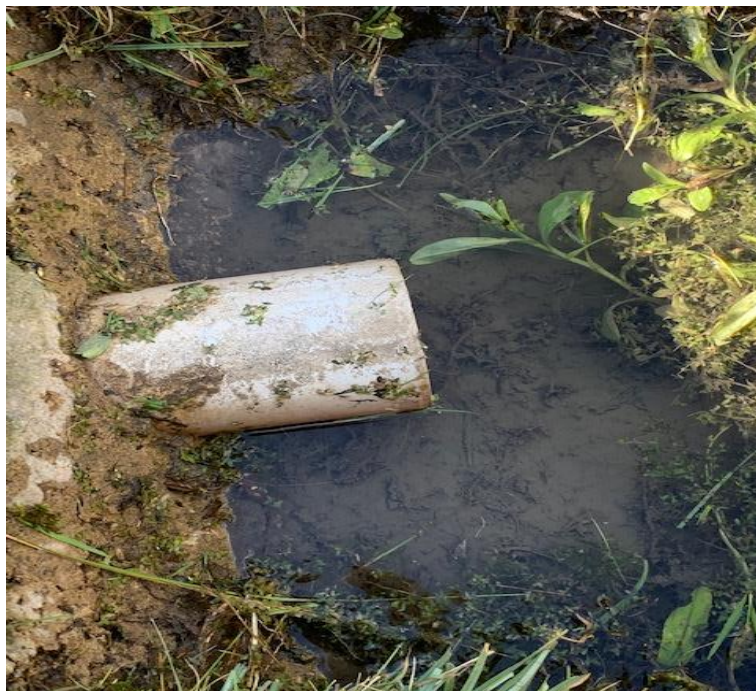
Outlet from Pond C, high level,
running clear, bottom photo shows

the inlet pipe to Pond D

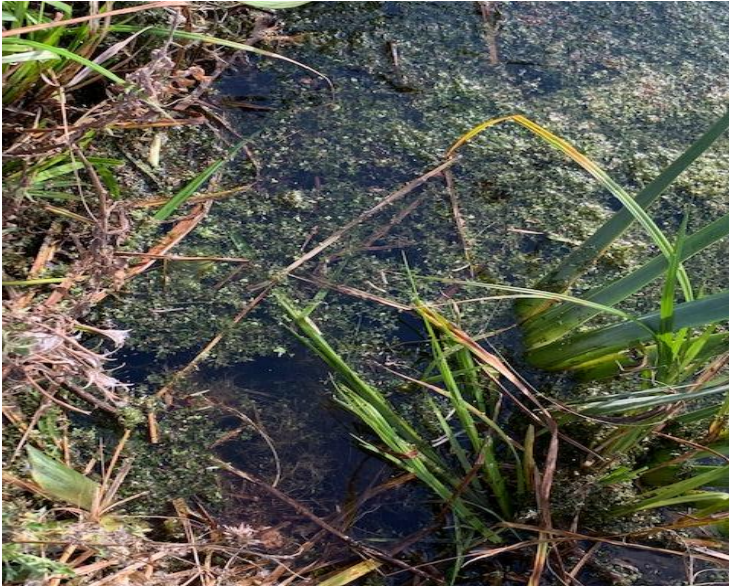
100mm land drain from the playing field, outfalling into Pond D

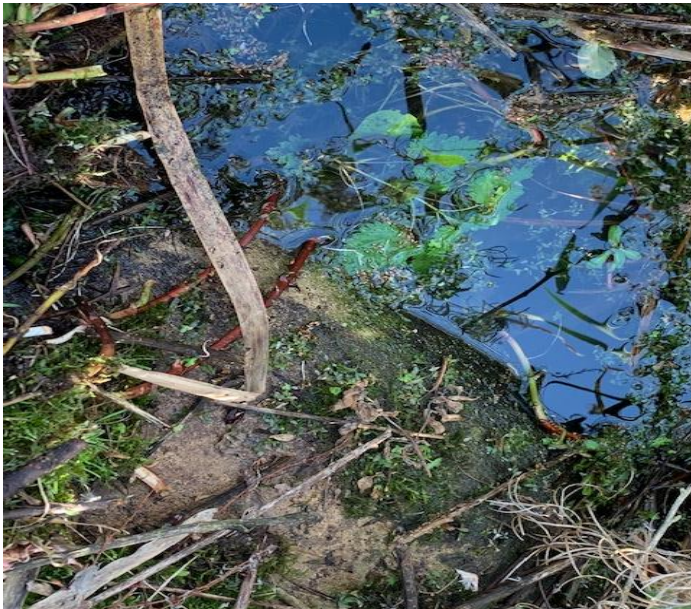
Outlet pipe from Pond D, low level.
Bottom photo shows low level pipe
inlet to Pond E.

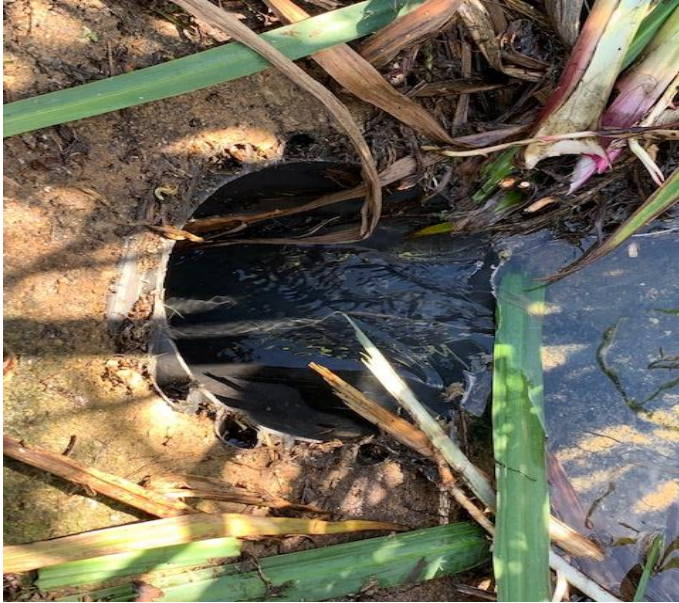
Pipe outlet from Pond E

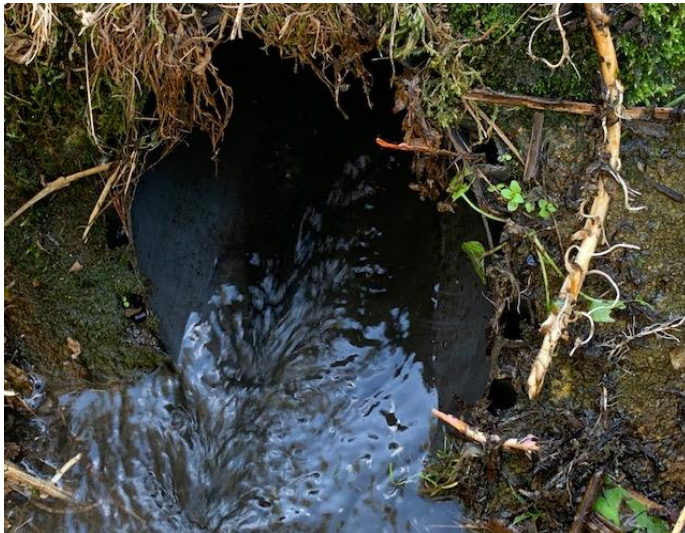
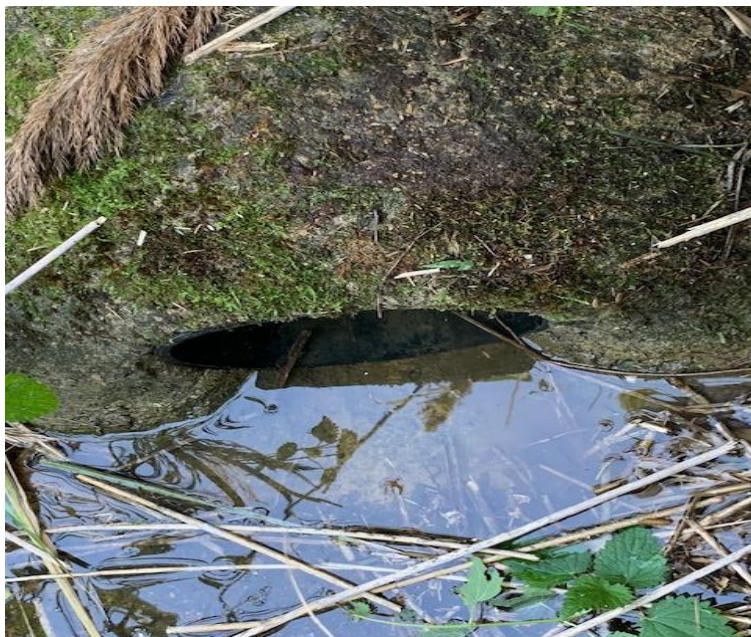
Inlet pipe to Reed Bed B, bottom photo shows the outlet pipe from Reed Bed B, this is a 150mm pipe added after the original low level pipe was installed. This was because the water did not drain quickly enough through the filter media. The 150mm pipe was installed to maintain the water level.
