Gordon Playground
Inspections LTD **PSSLive+**

Operational Inspection – December 2020

Churchdown Parish Council

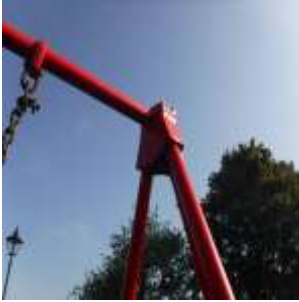
Asset Name	Finding Title	Finding Creation	Resolve By Date	Risk Level	Risk Value	Standard Ref	Cause
2 Bay 4 Flat Seat Swing	Chain - Cruxiform Connector(s) Worn - (previously reported)	21/09/2020	23/03/2021	Very Low	1 x 3 = 3		Wear and Tear

Task Title
Tighten loose fixtures & fittings

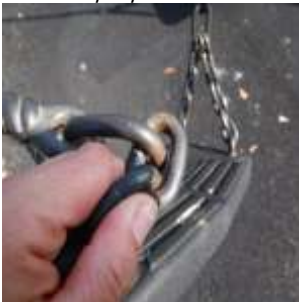
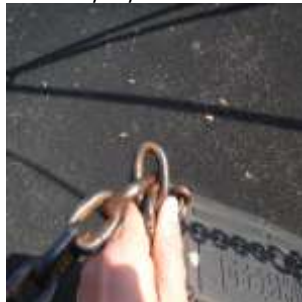
Asset Name	Finding Title	Finding Creation	Resolve By Date	Risk Level	Risk Value	Standard Ref	Cause
2 Bay 4 Flat Seat Swing	Chain - Links Worn - (previously reported)	21/09/2020	21/09/2021	Very Low	1 x 3 = 3		Wear and Tear

Task Title
Monitor

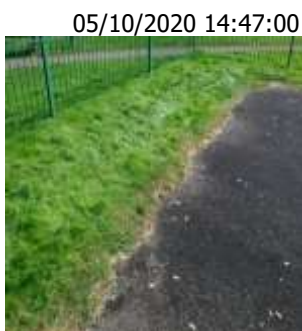
Standard Description: Surface has unintended grass, moss or weeds

Task Title
Remove grass, moss & weeds from playing surface

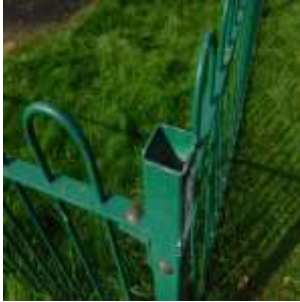
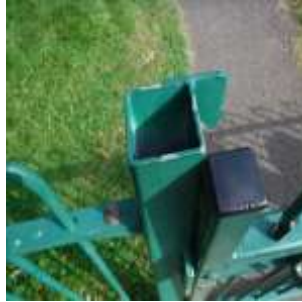
Asset Name	Finding Title	Finding Creation	Resolve By Date	Risk Level	Risk Value	Standard Ref	Cause
Fence	Item - Cap(s) missing - (previously reported)	21/09/2020	22/12/2020	Very Low	1 x 2 = 2		Wear and Tear

Replace

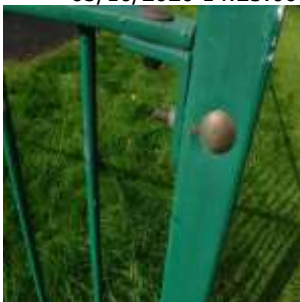
Asset Name	Finding Title	Finding Creation	Resolve By Date	Risk Level	Risk Value	Standard Ref	Cause
Fence	Finish - Bolts Protruding - (previously reported)	21/09/2020	23/03/2021	Very Low	1 x 2 = 2	EN 1176:2017 - 1 - 4.2.5	Installation Defect

Remove excessive threads

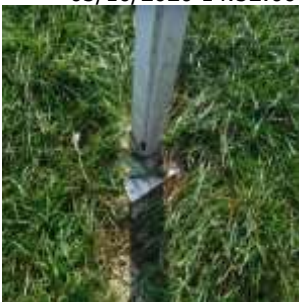
Asset Name	Finding Title	Finding Creation	Resolve By Date	Risk Level	Risk Value	Standard Ref	Cause
Goal Post	Item - Loose in Ground - (previously reported)	21/09/2020	23/03/2021	Very Low	1 x 1 = 1		Wear and Tear

Standard Description: Loose in ground

Repair item

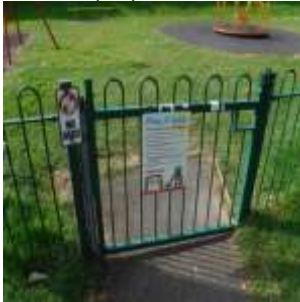
Asset Name	Finding Title	Finding Creation	Resolve By Date	Risk Level	Risk Value	Standard Ref	Cause
Pedestrian Gate	Entrapment - Head & Neck - (previously reported)	21/09/2020	21/09/2021	Very Low	1 x 3 = 3	EN 1176:2017 - 1 - 4.2.7.2	Manufacturer Defect

No action given the risk assessment

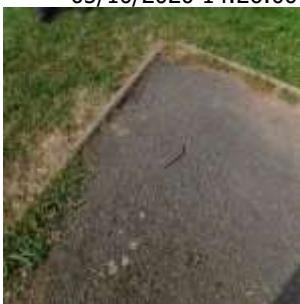
Asset Name	Finding Title	Finding Creation	Resolve By Date	Risk Level	Risk Value	Standard Ref	Cause
Pedestrian Gate	Surface - Trip points - (previously reported)	21/09/2020	22/12/2020	Low	2 x 3 = 6		Wear and Tear

Repair surface

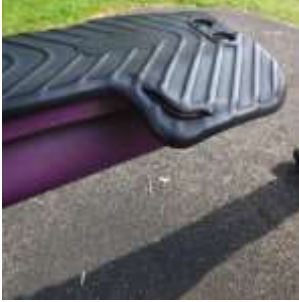
Asset Name	Finding Title	Finding Creation	Resolve By Date	Risk Level	Risk Value	Standard Ref	Cause
Seesaw	Item - Damaged - (previously reported)	21/09/2020	22/12/2020	Low	2 x 2 = 4		Wear and Tear

Standard Description: Item is damaged

Replace item

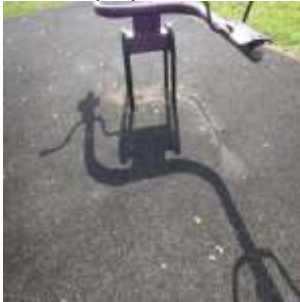
Asset Name	Finding Title	Finding Creation	Resolve By Date	Risk Level	Risk Value	Standard Ref	Cause
Seesaw Surface	Surface - Wearing - (previously reported)	21/09/2020	21/09/2021	Very Low	1 x 3 = 3		Wear and Tear

Standard Description: Surface wearing

Task Title
Monitor

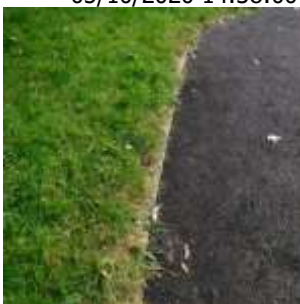
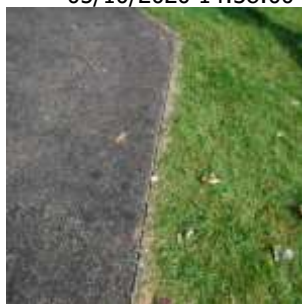
Asset Name	Finding Title	Finding Creation	Resolve By Date	Risk Level	Risk Value	Standard Ref	Cause
Seesaw Surface	Surface - Edges Shrunk - (previously reported)	21/09/2020	21/09/2021	Very Low	1 x 3 = 3		Wear and Tear

Task Title
Monitor

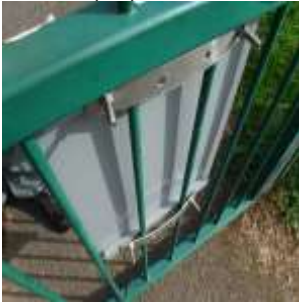
Asset Name	Finding Title	Finding Creation	Resolve By Date	Risk Level	Risk Value	Standard Ref	Cause
Signage	Finish - Bolts Protruding - (previously reported)	21/09/2020	22/12/2020	Low	2 x 2 = 4	EN 1176:2017 - 1 - 4.2.5	Installation Defect

Remove excessive threads

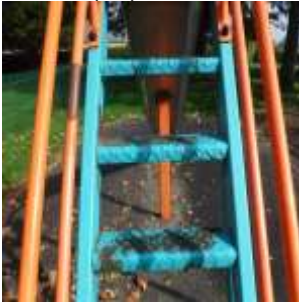
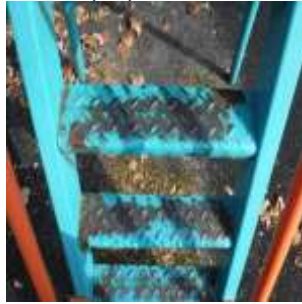
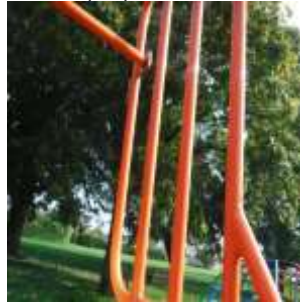
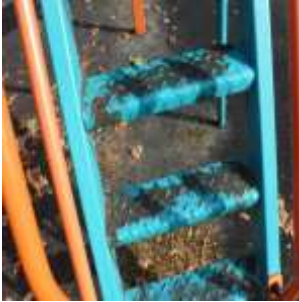
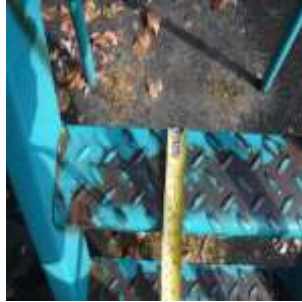
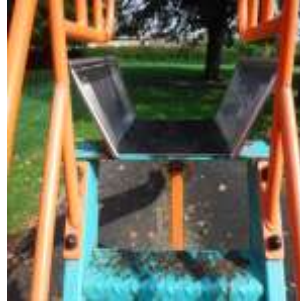
Asset Name	Finding Title	Finding Creation	Resolve By Date	Risk Level	Risk Value	Standard Ref	Cause
Slide	EN1176:2017 - Part 1 - Compliance - (previously reported)	21/09/2020	21/09/2021	Very Low	1 x 3 = 3	EN 1176:2017 - 1	Manufacturer Defect

No action required, based on risk assessment, as asset pre-dates EN 1176

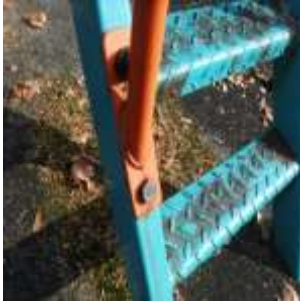
Asset Name	Finding Title	Finding Creation	Resolve By Date	Risk Level	Risk Value	Standard Ref	Cause
Slide	Item - Cap(s) missing - (previously reported)	21/09/2020	23/03/2021	Very Low	1 x 1 = 1		Wear and Tear

Standard Description: Cap(s) missing

Replace

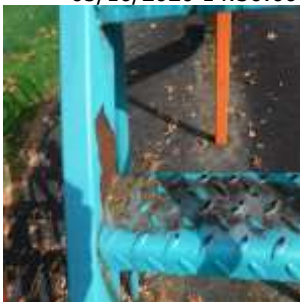
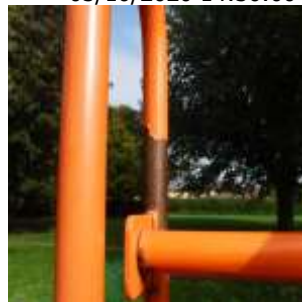
Asset Name	Finding Title	Finding Creation	Resolve By Date	Risk Level	Risk Value	Standard Ref	Cause
Slide	Item - Rusting in places - (previously reported)	21/09/2020	23/03/2021	Very Low	1 x 2 = 2		Wear and Tear

Standard Description: Item is rusting in places

De-rust and coat with paint meeting EN 1176 - 4.1.1 [1998]

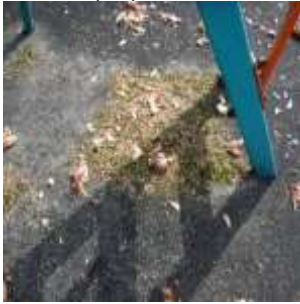
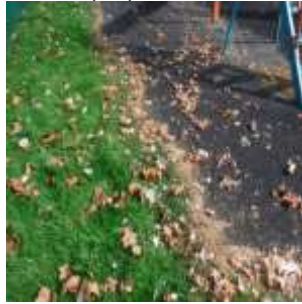
Asset Name	Finding Title	Finding Creation	Resolve By Date	Risk Level	Risk Value	Standard Ref	Cause
Slide Surface	Surface - Grass, Moss or Weeds - (previously reported)	21/09/2020	23/03/2021	Very Low	1 x 3 = 3		Routine

Remove grass, moss & weeds from playing surface

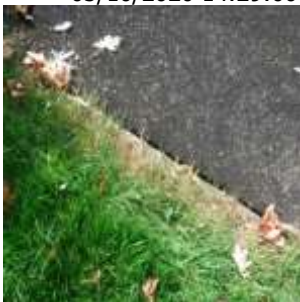
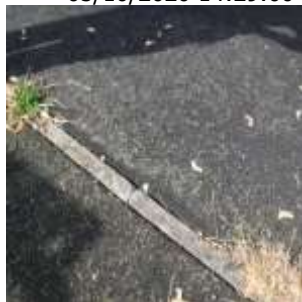
Asset Name	Finding Title	Finding Creation	Resolve By Date	Risk Level	Risk Value	Standard Ref	Cause
Slide Surface	Surface - Edges Shrunk - (previously reported)	21/09/2020	23/03/2021	Very Low	1 x 3 = 3		Wear and Tear

Monitor

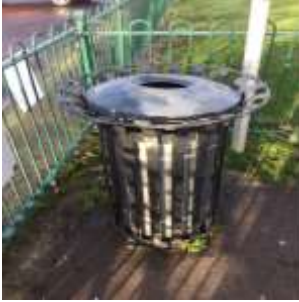
Asset Name	Finding Title	Finding Creation	Resolve By Date	Risk Level	Risk Value	Standard Ref	Cause
Bin	Bin - Not locked - (previously reported)	08/12/2020	10/03/2021	Very Low	1 x 3 = 3		Poor Maintenance

Lock Bin

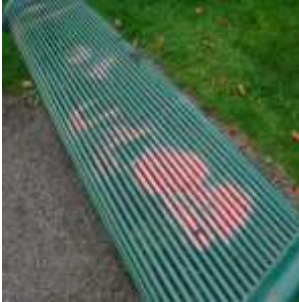
Asset Name	Finding Title	Finding Creation	Resolve By Date	Risk Level	Risk Value	Standard Ref	Cause
Bench x4	Item - Graffiti - Present - (previously reported)	21/09/2020	23/03/2021	Very Low	1 x 1 = 1		Vandalism

Remove graffiti

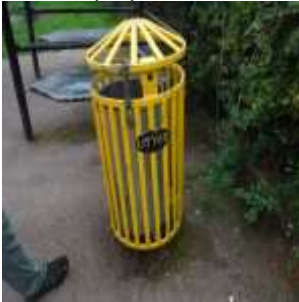
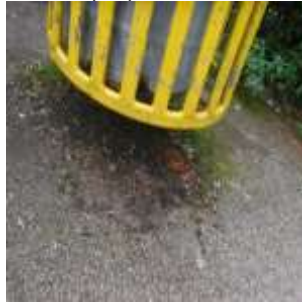
Asset Name	Finding Title	Finding Creation	Resolve By Date	Risk Level	Risk Value	Standard Ref	Cause
Bin (Rocket) x3	Item - Loose in Ground - (previously reported)	21/09/2020	21/09/2021	Very Low	1 x 2 = 2		Wear and Tear

Standard Description: Loose in ground

Monitor

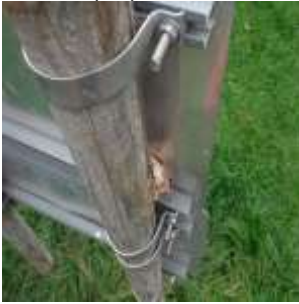
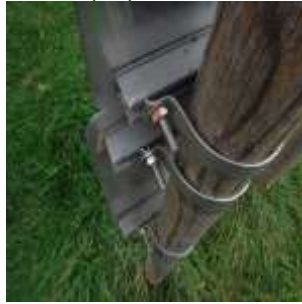
Asset Name	Finding Title	Finding Creation	Resolve By Date	Risk Level	Risk Value	Standard Ref	Cause
BMX Signage	Finish - Bolts Protruding - (previously reported)	21/09/2020	23/03/2021	Very Low	1 x 2 = 2	EN 1176:2017 - 1 - 4.2.5	Installation Defect

Remove excessive threads

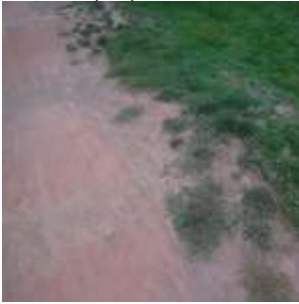
Asset Name	Finding Title	Finding Creation	Resolve By Date	Risk Level	Risk Value	Standard Ref	Cause
BMX Track	Surface - Weeds - (previously reported)	21/09/2020	22/12/2020	Low	2 x 3 = 6		Routine

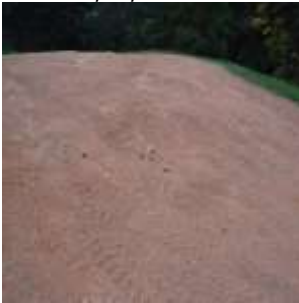
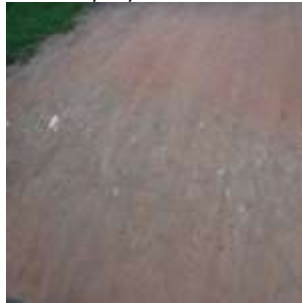
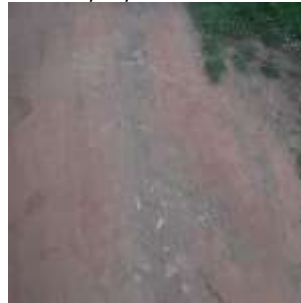
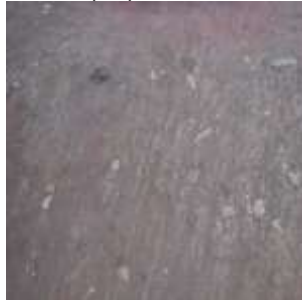
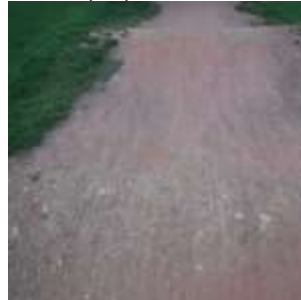
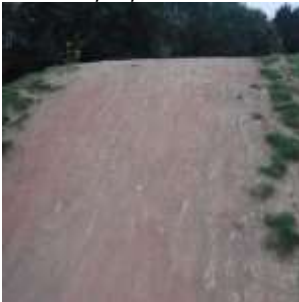
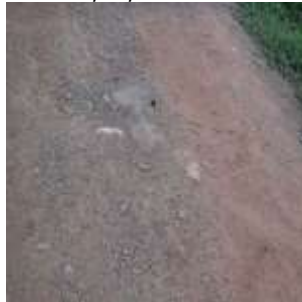
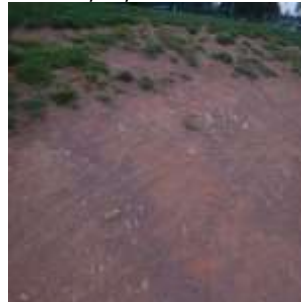
Asset Name	Finding Title	Finding Creation	Resolve By Date	Risk Level	Risk Value	Standard Ref	Cause
BMX Track	Surface - Wearing - (previously reported)	21/09/2020	22/12/2020	Low	3 x 3 = 9		Wear and Tear

Standard Description: Surface wearing

Finding Notes: There is heavy wear throughout the track

Replace surface

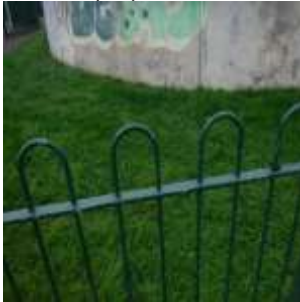
Asset Name	Finding Title	Finding Creation	Resolve By Date	Risk Level	Risk Value	Standard Ref	Cause
Fence - Bow Top	Entrapment - Head & Neck - (previously reported)	21/09/2020	21/09/2021	Very Low	1 x 3 = 3	EN 1176:2017 - 1 - 4.2.7.2	Manufacturer Defect

No action given the risk assessment

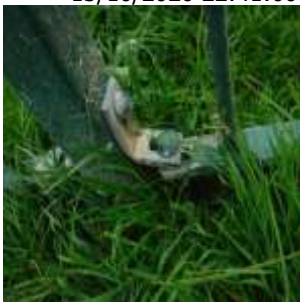
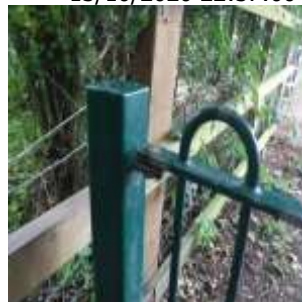
Asset Name	Finding Title	Finding Creation	Resolve By Date	Risk Level	Risk Value	Standard Ref	Cause
Fence - Bow Top	Fixtures - Loose or Missing - (previously reported)	21/09/2020	23/03/2021	Very Low	1 x 2 = 2		Wear and Tear

Standard Description: Fixtures loose or missing

Tighten loose fixtures & fittings

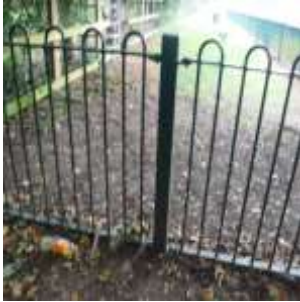
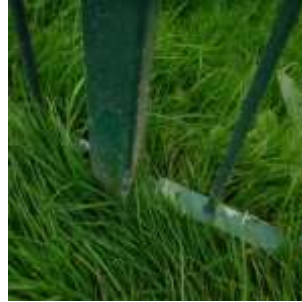
Asset Name	Finding Title	Finding Creation	Resolve By Date	Risk Level	Risk Value	Standard Ref	Cause
Fence - Bow Top	Item - Loose in Ground - (previously reported)	21/09/2020	21/09/2021	Very Low	1 x 2 = 2		Wear and Tear

Standard Description: Loose in ground

Monitor

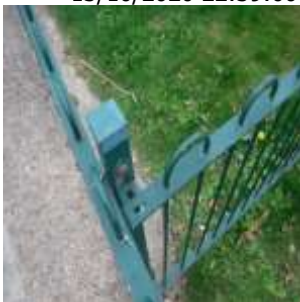
Asset Name	Finding Title	Finding Creation	Resolve By Date	Risk Level	Risk Value	Standard Ref	Cause
Fence - Bow Top	Fixtures - Loose or Missing - (previously reported)	21/09/2020	21/10/2020	Low	2 x 2 = 4		Wear and Tear

Standard Description: Fixtures loose or missing

Replace missing fasteners, fixtures and fitting

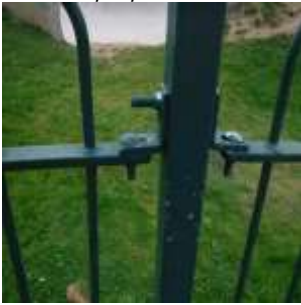
Asset Name	Finding Title	Finding Creation	Resolve By Date	Risk Level	Risk Value	Standard Ref	Cause
Fence - Bow Top	Finish - Bolts Protruding - (previously reported)	21/09/2020	23/03/2021	Very Low	1 x 2 = 2	EN 1176:2017 - 1 - 4.2.5	Poor Maintenance

Task Title
Remove excessive threads

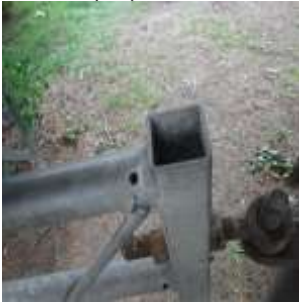
Asset Name	Finding Title	Finding Creation	Resolve By Date	Risk Level	Risk Value	Standard Ref	Cause
Kissing Gate	Item - Cap(s) missing - (previously reported)	21/09/2020	23/03/2021	Very Low	1 x 2 = 2		Wear and Tear

Standard Description: Cap(s) missing

Replace

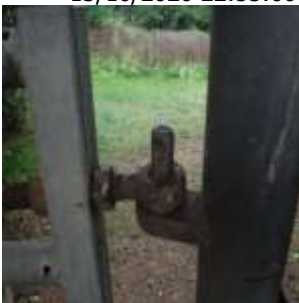
Asset Name	Finding Title	Finding Creation	Resolve By Date	Risk Level	Risk Value	Standard Ref	Cause
Kissing Gate	Item - Incorrectly Installed - (previously reported)	21/09/2020	23/03/2021	Very Low	1 x 2 = 2		Installation Defect

Repair item

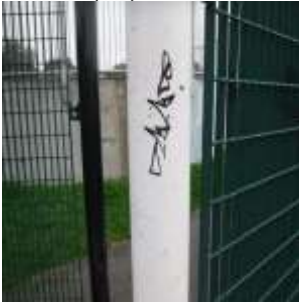
Asset Name	Finding Title	Finding Creation	Resolve By Date	Risk Level	Risk Value	Standard Ref	Cause
MUGA	Item - Graffiti - Present - (previously reported)	21/09/2020	23/03/2021	Very Low	1 x 1 = 1		Vandalism

Remove graffiti

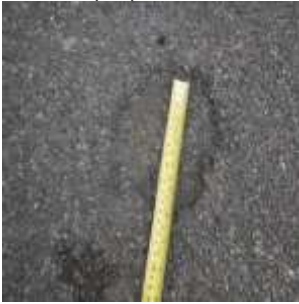
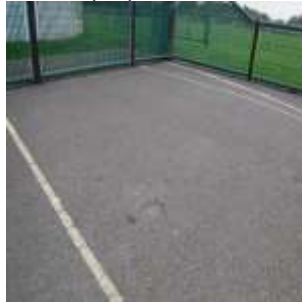
Asset Name	Finding Title	Finding Creation	Resolve By Date	Risk Level	Risk Value	Standard Ref	Cause
MUGA Surface	Surface - Trip points - (previously reported)	21/09/2020	23/03/2021	Very Low	1 x 3 = 3		Wear and Tear

Repair surface

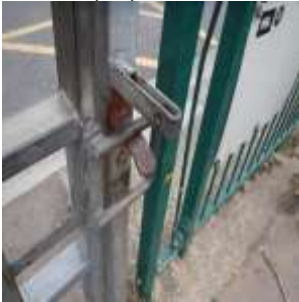
Asset Name	Finding Title	Finding Creation	Resolve By Date	Risk Level	Risk Value	Standard Ref	Cause
Pedestrian Gate	Item - Parts Missing - (previously reported)	21/09/2020	22/12/2020	Very Low	1 x 2 = 2		Wear and Tear

Standard Description: Item has some parts missing

Replace missing parts

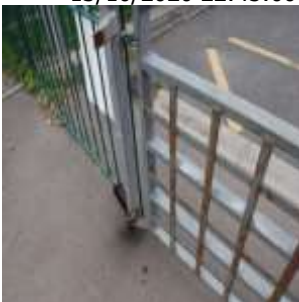
Asset Name	Finding Title	Finding Creation	Resolve By Date	Risk Level	Risk Value	Standard Ref	Cause
Pedestrian Gate	Gate - Self-Closing - Adjustment - (previously reported)	21/09/2020	22/12/2020	Low	2 x 4 = 8		Wear and Tear

Adjust self-closure mechanism

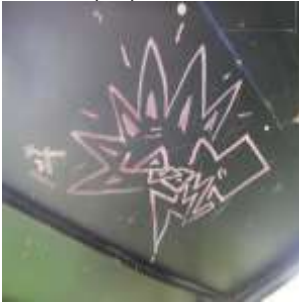
Asset Name	Finding Title	Finding Creation	Resolve By Date	Risk Level	Risk Value	Standard Ref	Cause
Shelter	Item - Graffiti - Present - (previously reported)	21/09/2020	23/03/2021	Very Low	1 x 1 = 1		Vandalism

Remove graffiti

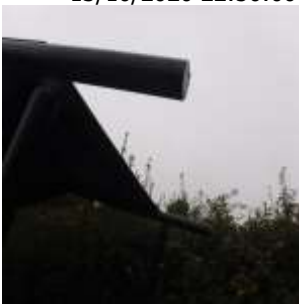
Asset Name	Finding Title	Finding Creation	Resolve By Date	Risk Level	Risk Value	Standard Ref	Cause
Shelter	Item - Parts Missing - (previously reported)	21/09/2020	23/03/2021	Very Low	1 x 1 = 1		Wear and Tear

Standard Description: Item has some parts missing

Replace missing parts

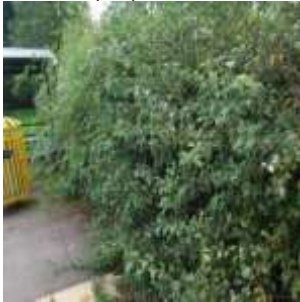
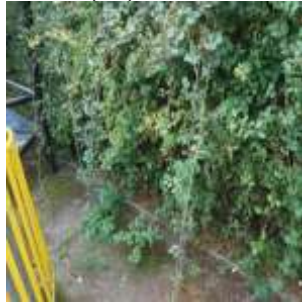
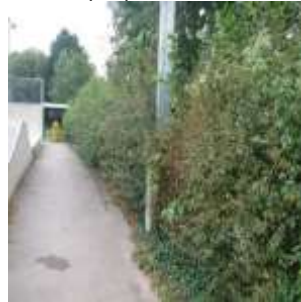
Asset Name	Finding Title	Finding Creation	Resolve By Date	Risk Level	Risk Value	Standard Ref	Cause
Site - Churchdown Park - BMX, MUGA and Skate	Surface - Encroaching vegetation/trees - (previously reported)	21/09/2020	22/12/2020	Low	3 x 2 = 6		Routine

Cut back vegetation/trees

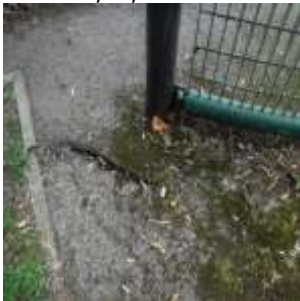
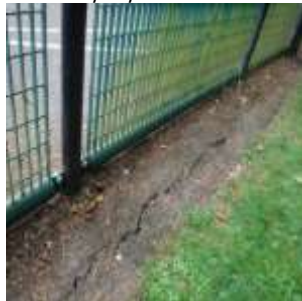
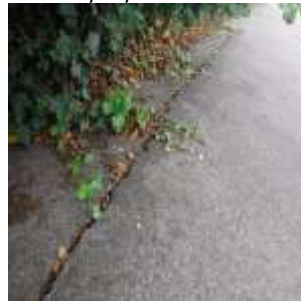
Asset Name	Finding Title	Finding Creation	Resolve By Date	Risk Level	Risk Value	Standard Ref	Cause
Site - Churchdown Park - BMX, MUGA and Skate	Item - Cracked - (previously reported)	21/09/2020	21/09/2021	Very Low	1 x 2 = 2		Wear and Tear

Standard Description: Item is cracked

Monitor

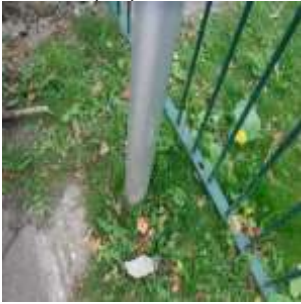
Asset Name	Finding Title	Finding Creation	Resolve By Date	Risk Level	Risk Value	Standard Ref	Cause
Skate - Signage	Item - Loose in Ground - (previously reported)	21/09/2020	21/09/2021	Very Low	1 x 2 = 2		Wear and Tear

Monitor

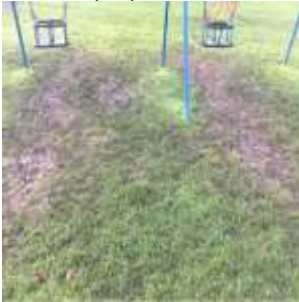
08/12/2020 09:52:00

Asset Name	Finding Title	Finding Creation	Resolve By Date	Risk Level	Risk Value	Standard Ref	Cause
2 Bay 4 Cradle Seat Swing Surface	Ground Eroded - (previously reported)	08/12/2020	10/03/2021	Low	1 x 4 = 4		Wear and Tear

Task Title
Make good surface

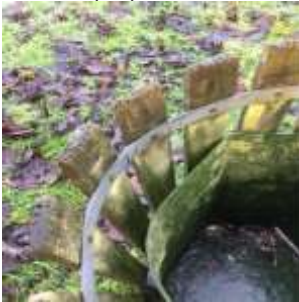
08/12/2020 09:38:00

Asset Name	Finding Title	Finding Creation	Resolve By Date	Risk Level	Risk Value	Standard Ref	Cause
Bin (Timber)	Item - Hard or Sharp Projections - (previously reported)	08/12/2020	10/03/2021	Very Low	1 x 2 = 2		Wear and Tear

Remove hard, pointed & sharp projections

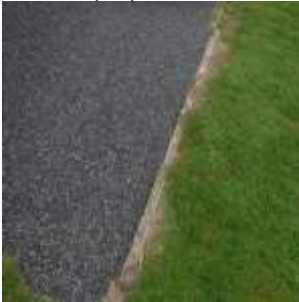
14/10/2020 00:14:00

Asset Name	Finding Title	Finding Creation	Resolve By Date	Risk Level	Risk Value	Standard Ref	Cause
1 Bay 2 Cradle Seat Swing Surface	Surface - Edges Shrunk - (previously reported)	21/09/2020	21/09/2021	Very Low	1 x 2 = 2		Wear and Tear

Monitor

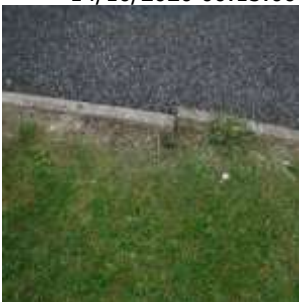
14/10/2020 00:15:00

Asset Name	Finding Title	Finding Creation	Resolve By Date	Risk Level	Risk Value	Standard Ref	Cause
1 Bay 2 Cradle Seat Swing Surface	Surface - Trip points - (previously reported)	21/09/2020	22/12/2020	Low	2 x 3 = 6		Wear and Tear

Repair surface

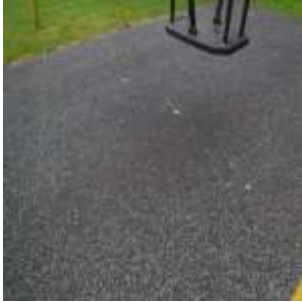
14/10/2020 00:16:00

Asset Name	Finding Title	Finding Creation	Resolve By Date	Risk Level	Risk Value	Standard Ref	Cause
1 Bay 2 Cradle Seat Swing Surface	Surface - Wearing - (previously reported)	21/09/2020	23/03/2021	Very Low	1 x 2 = 2		Wear and Tear

Standard Description: Surface wearing

Monitor

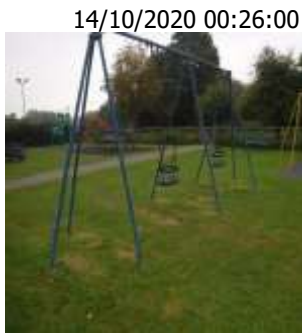
Asset Name	Finding Title	Finding Creation	Resolve By Date	Risk Level	Risk Value	Standard Ref	Cause
2 Bay 4 Cradle Seat Swing	Swing - Seats - Missing - (previously reported)	21/09/2020	23/03/2021	Very Low	1 x 1 = 1		Routine

Standard Description: Swing seats missing

Finding Notes: Seats removed as a Covid 19 social distancing measure

No action given the risk assessment

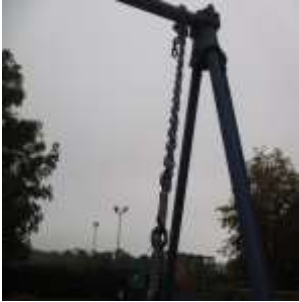
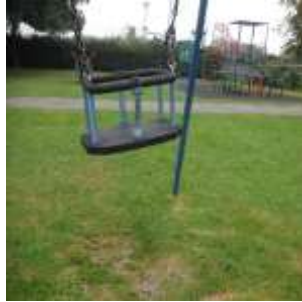
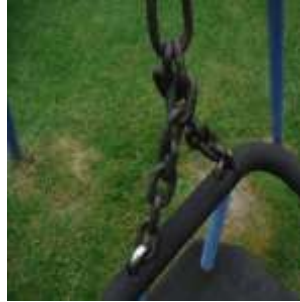
Asset Name	Finding Title	Finding Creation	Resolve By Date	Risk Level	Risk Value	Standard Ref	Cause
2 Bay 4 Cradle Seat Swing	Swing - Chains twisted - (previously reported)	21/09/2020	23/03/2021	Very Low	1 x 1 = 1		Poor Maintenance

Refit chains

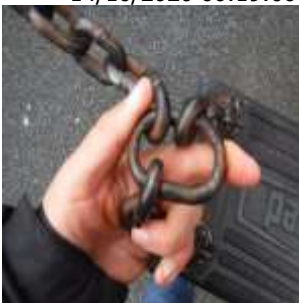
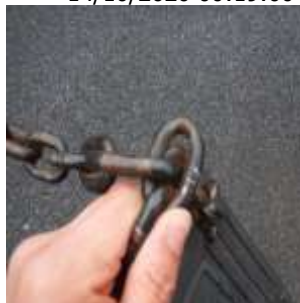
Asset Name	Finding Title	Finding Creation	Resolve By Date	Risk Level	Risk Value	Standard Ref	Cause
2 Bay 4 Flat Seat Swing	Chain - Links Worn - (previously reported)	21/09/2020	21/09/2021	Very Low	1 x 3 = 3		Wear and Tear

Standard Description: Chains links worn

Monitor

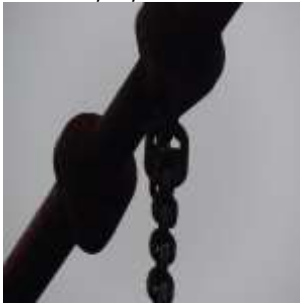
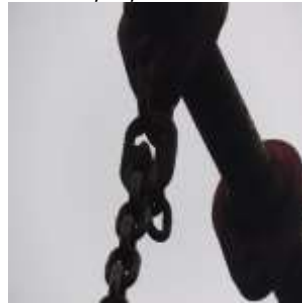
Asset Name	Finding Title	Finding Creation	Resolve By Date	Risk Level	Risk Value	Standard Ref	Cause
2 Bay 4 Flat Seat Swing	Chain - Cruxiform Connector(s) Worn - (previously reported)	21/09/2020	23/03/2021	Very Low	1 x 3 = 3		Wear and Tear

Standard Description: The cruxiform chain connector is worn.

Replace cruxiform connector(s)

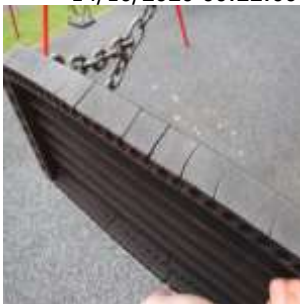
14/10/2020 00:22:00

Asset Name	Finding Title	Finding Creation	Resolve By Date	Risk Level	Risk Value	Standard Ref	Cause
2 Bay 4 Flat Seat Swing	Swing - Seat(s) - Damaged - (previously reported)	21/09/2020	21/09/2021	Very Low	1 x 2 = 2		Wear and Tear

Standard Description: Swing seat damaged

Monitor

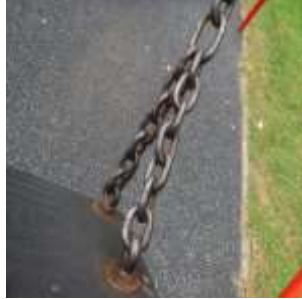
14/10/2020 00:20:00

Asset Name	Finding Title	Finding Creation	Resolve By Date	Risk Level	Risk Value	Standard Ref	Cause
2 Bay 4 Flat Seat Swing	Swing - Chains twisted - (previously reported)	21/09/2020	23/03/2021	Very Low	1 x 1 = 1		Poor Maintenance

Refit chains

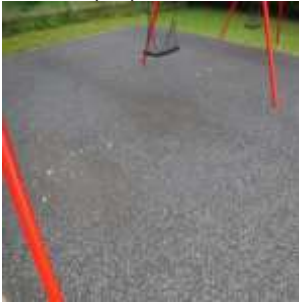
14/10/2020 00:17:00

Asset Name	Finding Title	Finding Creation	Resolve By Date	Risk Level	Risk Value	Standard Ref	Cause
2 Bay 4 Flat Seat Swing Surface	Surface - Wearing - (previously reported)	21/09/2020	21/09/2021	Very Low	1 x 2 = 2		Wear and Tear

Standard Description: Surface wearing

Monitor

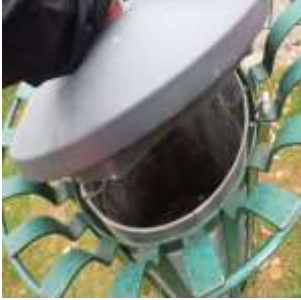
13/10/2020 23:40:00

Asset Name	Finding Title	Finding Creation	Resolve By Date	Risk Level	Risk Value	Standard Ref	Cause
Bin (Metal)	Bin - Not locked - (previously reported)	21/09/2020	21/10/2020	Very Low	1 x 2 = 2		Poor Maintenance

Lock Bin

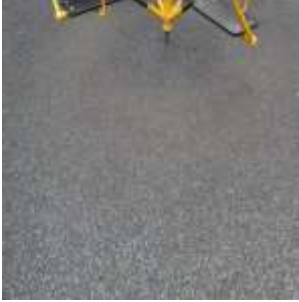
14/10/2020 00:22:00

Asset Name	Finding Title	Finding Creation	Resolve By Date	Risk Level	Risk Value	Standard Ref	Cause
Carousel - Whirly Bird Surface	Surface - Wearing - (previously reported)	21/09/2020	21/09/2021	Very Low	1 x 2 = 2		Wear and Tear

Standard Description: Surface wearing

Monitor

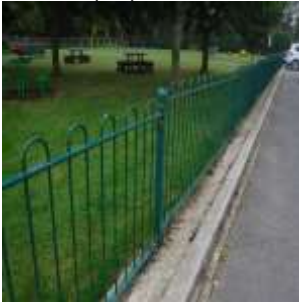
13/10/2020 23:35:00

Asset Name	Finding Title	Finding Creation	Resolve By Date	Risk Level	Risk Value	Standard Ref	Cause
Fence - Bow Top	Entrapment - Head & Neck - (previously reported)	21/09/2020	21/09/2021	Very Low	1 x 3 = 3	EN 1176:2017 - 1 - 4.2.7.2	Manufacturer Defect

No action given the risk assessment

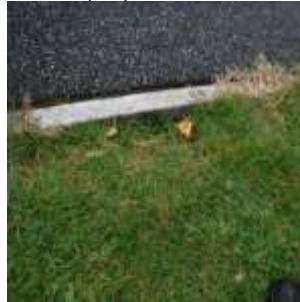
Asset Name	Finding Title	Finding Creation	Resolve By Date	Risk Level	Risk Value	Standard Ref	Cause
Junior Multiplay Surface	Surface - Trip points - (previously reported)	21/09/2020	23/03/2021	Very Low	1 x 3 = 3		Wear and Tear

Monitor

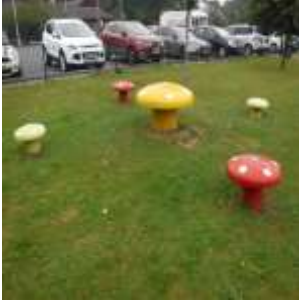
Asset Name	Finding Title	Finding Creation	Resolve By Date	Risk Level	Risk Value	Standard Ref	Cause
Mushroom x5	Ground Eroded - (previously reported)	21/09/2020	23/03/2021	Very Low	1 x 3 = 3		Wear and Tear

Make good surface

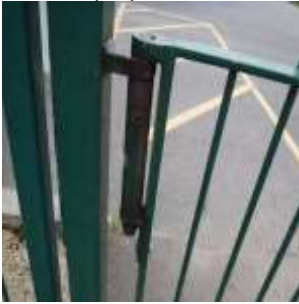
Asset Name	Finding Title	Finding Creation	Resolve By Date	Risk Level	Risk Value	Standard Ref	Cause
Pedestrian Gate (Metal)	Gate - Violent Action - (previously reported)	21/09/2020	22/12/2020	Low	2 x 4 = 8		Wear and Tear

Adjust self-closure mechanism

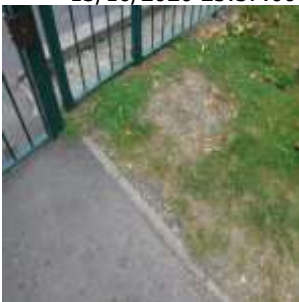
Asset Name	Finding Title	Finding Creation	Resolve By Date	Risk Level	Risk Value	Standard Ref	Cause
Pedestrian Gate (Metal)	Ground Eroded - (previously reported)	21/09/2020	23/03/2021	Very Low	1 x 3 = 3		Wear and Tear

Make good surface

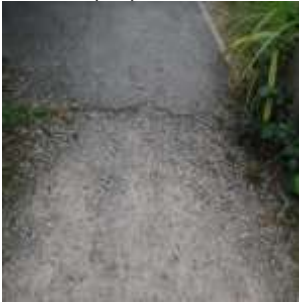
Asset Name	Finding Title	Finding Creation	Resolve By Date	Risk Level	Risk Value	Standard Ref	Cause
Pedestrian Gate (Timber)	Surface - Trip points - (previously reported)	21/09/2020	22/12/2020	Low	2 x 3 = 6		Wear and Tear

Repair surface

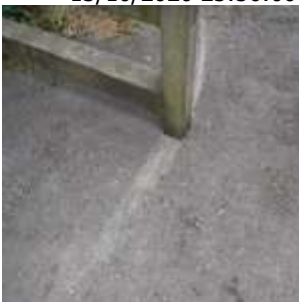
Asset Name	Finding Title	Finding Creation	Resolve By Date	Risk Level	Risk Value	Standard Ref	Cause
Pedestrian Gate (Timber)	Gate - Sticking on the ground - (previously reported)	21/09/2020	22/12/2020	Low	2 x 2 = 4		Wear and Tear

Repair item

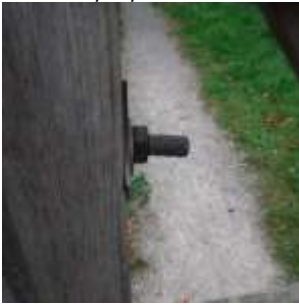
Asset Name	Finding Title	Finding Creation	Resolve By Date	Risk Level	Risk Value	Standard Ref	Cause
Pedestrian Gate (Timber)	Finish - Bolts Protruding - (previously reported)	21/09/2020	22/12/2020	Low	2 x 2 = 4	EN 1176:2017 - 1 - 4.2.5	Installation Defect

Task Title
Remove excessive threads

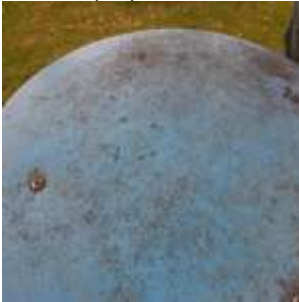
Asset Name	Finding Title	Finding Creation	Resolve By Date	Risk Level	Risk Value	Standard Ref	Cause
Picnic Table (Kids)	Item - Requires cleaning - (previously reported)	21/09/2020	23/03/2021	Very Low	1 x 1 = 1		Routine

Clean Item

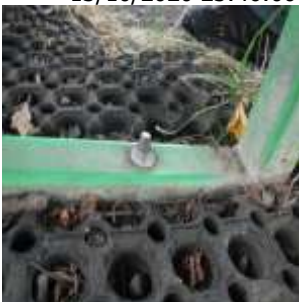
Asset Name	Finding Title	Finding Creation	Resolve By Date	Risk Level	Risk Value	Standard Ref	Cause
Picnic Table (Kids)	Finish - Bolts Protruding - (previously reported)	21/09/2020	22/12/2020	Low	2 x 2 = 4	EN 1176:2017 - 1 - 4.2.5	Installation Defect

Remove excessive threads

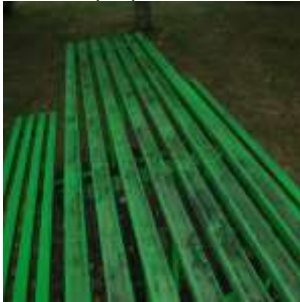
Asset Name	Finding Title	Finding Creation	Resolve By Date	Risk Level	Risk Value	Standard Ref	Cause
Picnic Table (Metal)	Item - Requires cleaning - (previously reported)	21/09/2020	23/03/2021	Very Low	1 x 1 = 1		Routine

Clean Item

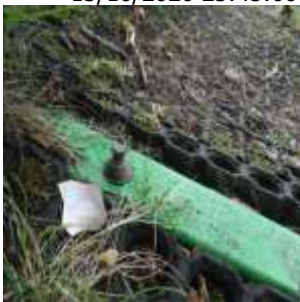
Asset Name	Finding Title	Finding Creation	Resolve By Date	Risk Level	Risk Value	Standard Ref	Cause
Picnic Table (Metal)	Finish - Bolts Protruding - (previously reported)	21/09/2020	22/12/2020	Low	2 x 2 = 4	EN 1176:2017 - 1 - 4.2.5	Installation Defect

Remove excessive threads

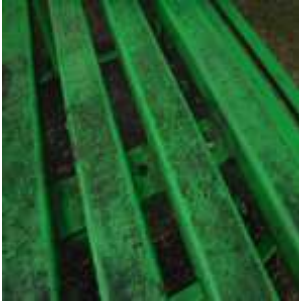
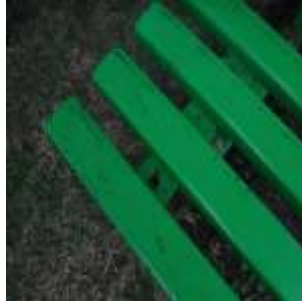
Asset Name	Finding Title	Finding Creation	Resolve By Date	Risk Level	Risk Value	Standard Ref	Cause
Picnic Table (Metal)	Fixtures - Loose or Missing - (previously reported)	21/09/2020	23/03/2021	Very Low	1 x 1 = 1		Wear and Tear

Standard Description: Fixtures loose or missing

Replace missing fasteners, fixtures and fitting

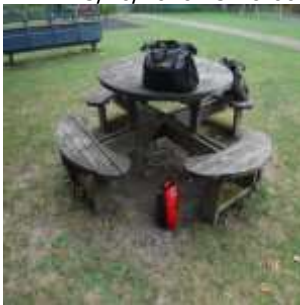
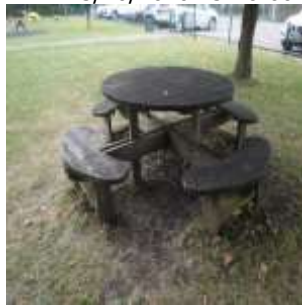
Asset Name	Finding Title	Finding Creation	Resolve By Date	Risk Level	Risk Value	Standard Ref	Cause
Picnic Table (Timber) x2	Item - Requires cleaning - (previously reported)	21/09/2020	23/03/2021	Very Low	1 x 1 = 1		Routine

Task Title
Clean Item

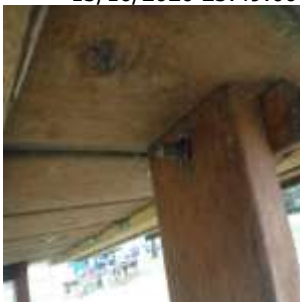
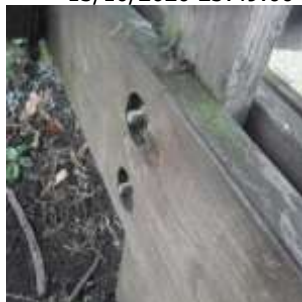
Asset Name	Finding Title	Finding Creation	Resolve By Date	Risk Level	Risk Value	Standard Ref	Cause
Picnic Table (Timber) x2	Finish - Bolts Protruding - (previously reported)	21/09/2020	22/12/2020	Low	2 x 2 = 4	EN 1176:2017 - 1 - 4.2.5	Installation Defect

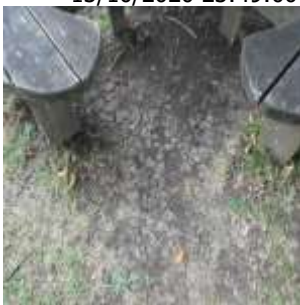
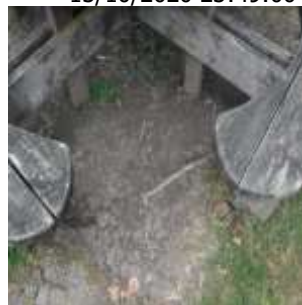
Asset Name	Finding Title	Finding Creation	Resolve By Date	Risk Level	Risk Value	Standard Ref	Cause
Picnic Table (Timber) x2	Ground Eroded - (previously reported)	21/09/2020	23/03/2021	Very Low	1 x 3 = 3		Wear and Tear

Task Title
Make good surface

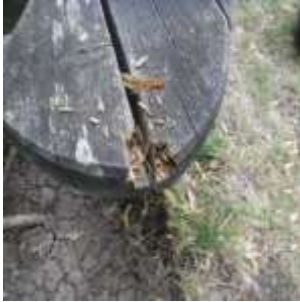
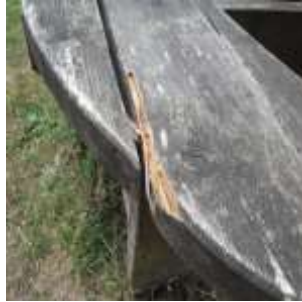
Asset Name	Finding Title	Finding Creation	Resolve By Date	Risk Level	Risk Value	Standard Ref	Cause
Picnic Table (Timber) x2	Timber - Splintered - (previously reported)	21/09/2020	22/12/2020	Low	2 x 2 = 4		Wear and Tear

Remove splinters

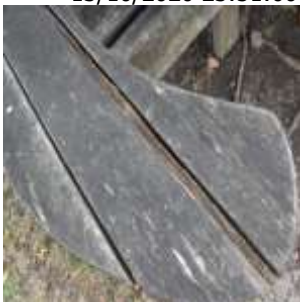
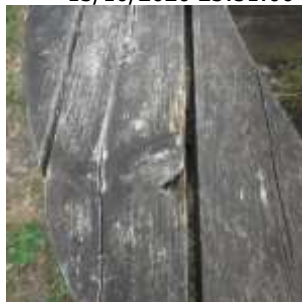
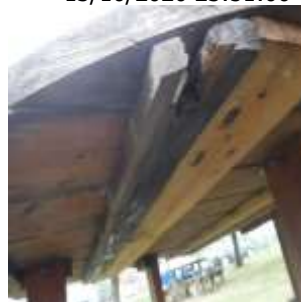
Asset Name	Finding Title	Finding Creation	Resolve By Date	Risk Level	Risk Value	Standard Ref	Cause
Picnic Table (Timber) x2	Timber - Not in Good Condition - (previously reported)	21/09/2020	21/09/2021	Very Low	1 x 2 = 2		Wear and Tear

Standard Description: Timber condition

Monitor

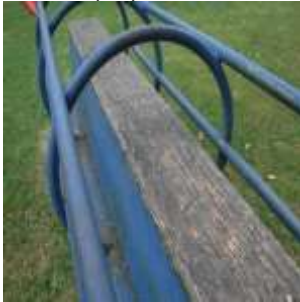
Asset Name	Finding Title	Finding Creation	Resolve By Date	Risk Level	Risk Value	Standard Ref	Cause
Rocket	Timber - Not in Good Condition - (previously reported)	21/09/2020	21/09/2021	Very Low	1 x 2 = 2		Wear and Tear

Standard Description: Timber condition

Monitor

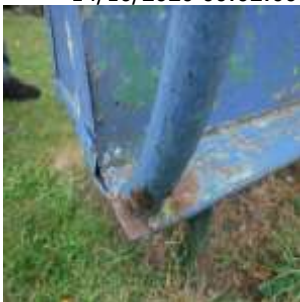
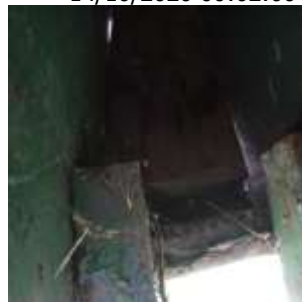
Asset Name	Finding Title	Finding Creation	Resolve By Date	Risk Level	Risk Value	Standard Ref	Cause
Rocket	Metal - Excessive Corrosion - (previously reported)	21/09/2020	21/09/2021	Very Low	1 x 2 = 2		Wear and Tear

Standard Description: Metal excessive corrosion

Monitor

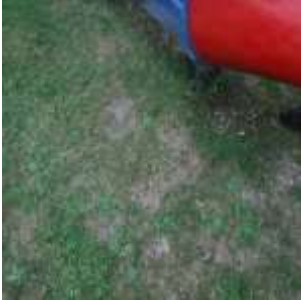
Asset Name	Finding Title	Finding Creation	Resolve By Date	Risk Level	Risk Value	Standard Ref	Cause
Rocket Surface	Ground Eroded - (previously reported)	21/09/2020	23/03/2021	Very Low	1 x 3 = 3		Wear and Tear

Make good surface

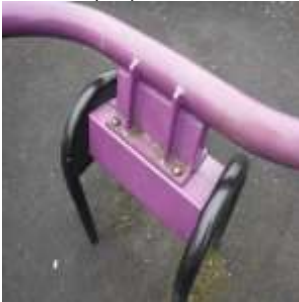
Asset Name	Finding Title	Finding Creation	Resolve By Date	Risk Level	Risk Value	Standard Ref	Cause
Seesaw	Item - Bearings Worn - (previously reported)	21/09/2020	21/09/2021	Very Low	1 x 3 = 3		Wear and Tear

Monitor

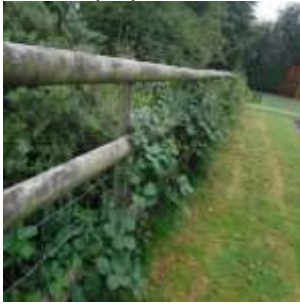
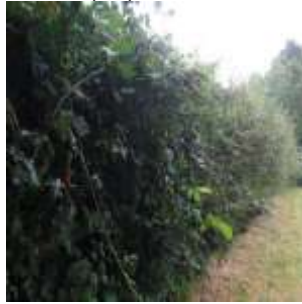
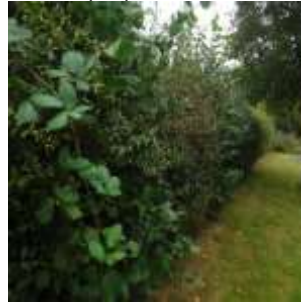
Asset Name	Finding Title	Finding Creation	Resolve By Date	Risk Level	Risk Value	Standard Ref	Cause
Site - Churchdown Park - Play Area	Surface - Encroaching vegetation/trees - (previously reported)	21/09/2020	22/12/2020	Low	3 x 2 = 6		Routine

Task Title
Cut back vegetation/trees

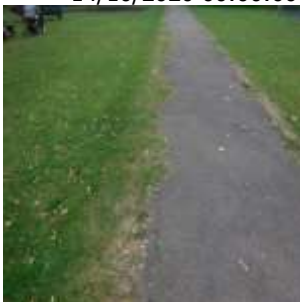
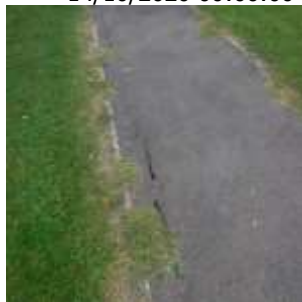
Asset Name	Finding Title	Finding Creation	Resolve By Date	Risk Level	Risk Value	Standard Ref	Cause
Site - Churchdown Park - Play Area	Surface - Weeds - (previously reported)	21/09/2020	23/03/2021	Very Low	1 x 2 = 2		Routine

Task Title
Remove weeds

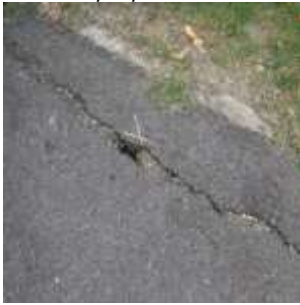
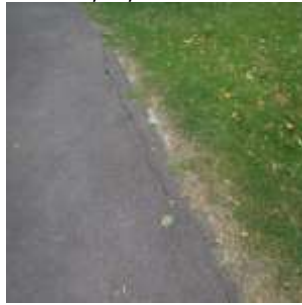
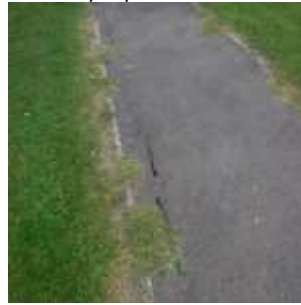
Asset Name	Finding Title	Finding Creation	Resolve By Date	Risk Level	Risk Value	Standard Ref	Cause
Site - Churchdown Park - Play Area	Item - Cracked - (previously reported)	21/09/2020	21/09/2021	Very Low	1 x 3 = 3		Wear and Tear

Standard Description: Item is cracked

Monitor

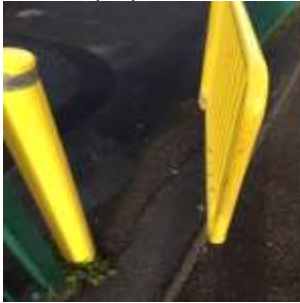
Asset Name	Finding Title	Finding Creation	Resolve By Date	Risk Level	Risk Value	Standard Ref	Cause
Pedestrian Gate	Gate - Self-Closing - Adjustment - (previously reported)	08/12/2020	07/01/2021	Low	2 x 3 = 6		Wear and Tear

Adjust self-closure mechanism

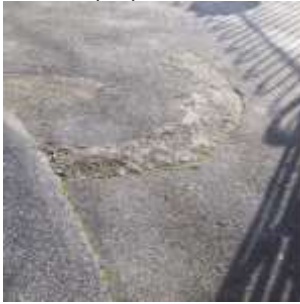
Asset Name	Finding Title	Finding Creation	Resolve By Date	Risk Level	Risk Value	Standard Ref	Cause
Site - Innia Play Area	Surface - Uneven - (previously reported)	08/12/2020	09/06/2021	Low	2 x 2 = 4		Wear and Tear

Task Title
Repair surface

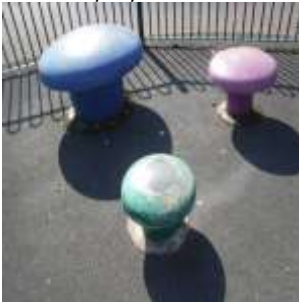
Asset Name	Finding Title	Finding Creation	Resolve By Date	Risk Level	Risk Value	Standard Ref	Cause
Mushroom x3	Falling Space - Obstacles - (previously reported)	21/09/2020	21/09/2021	Very Low	1 x 3 = 3	EN 1176:2017 - 1 - 4.2.8.4	Installation Defect

Standard Description: The falling space contains obstacles or equipment parts onto which a user could fall and cause injuries.

No action given the risk assessment

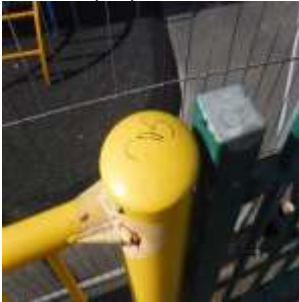
Asset Name	Finding Title	Finding Creation	Resolve By Date	Risk Level	Risk Value	Standard Ref	Cause
Pedestrian Gate	Item - Graffiti - Present - (previously reported)	21/09/2020	23/03/2021	Very Low	1 x 1 = 1		Vandalism

Remove graffiti

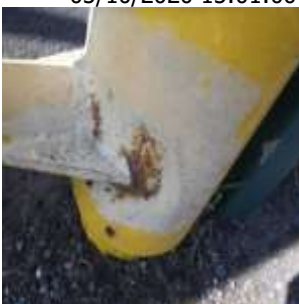
Asset Name	Finding Title	Finding Creation	Resolve By Date	Risk Level	Risk Value	Standard Ref	Cause
Pedestrian Gate	Metal - Welds are Cracked - (previously reported)	21/09/2020	23/03/2021	Very Low	1 x 2 = 2		Wear and Tear

Standard Description: Metal weld cracks

Reweld

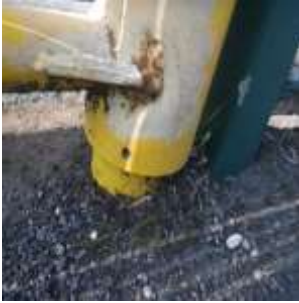
Asset Name	Finding Title	Finding Creation	Resolve By Date	Risk Level	Risk Value	Standard Ref	Cause
Pedestrian Gate	Fixtures - Loose or Missing - (previously reported)	21/09/2020	23/03/2021	Very Low	1 x 1 = 1		Wear and Tear

Standard Description: Fixtures loose or missing

Replace missing fasteners, fixtures and fitting

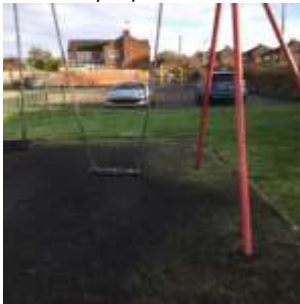
Asset Name	Finding Title	Finding Creation	Resolve By Date	Risk Level	Risk Value	Standard Ref	Cause
2 Bay 4 Flat Seat Swing	Swing - Adjust seat height - (previously reported)	08/12/2020	07/01/2021	Low	2 x 3 = 6		Poor Maintenance

Finding Notes: Seat has been incorrectly fitted when replaced after COVID removal /replacement

Adjust seat height

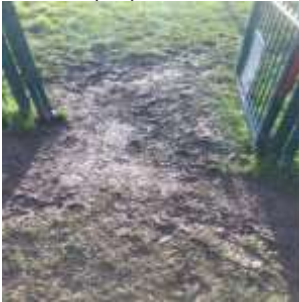
Asset Name	Finding Title	Finding Creation	Resolve By Date	Risk Level	Risk Value	Standard Ref	Cause
Pedestrian Gate x2	Ground Eroded - (previously reported)	08/12/2020	10/03/2021	Very Low	1 x 3 = 3		Wear and Tear

Make good surface

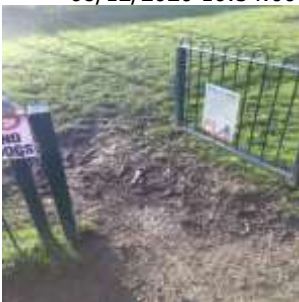
Asset Name	Finding Title	Finding Creation	Resolve By Date	Risk Level	Risk Value	Standard Ref	Cause
Pedestrian Gate x2	Gate - Sticking on the ground - (previously reported)	08/12/2020	09/01/2021 Edited on 09/12/2020 17:30:01	Low	2 x 2 = 4 Edited on 09/12/2020 17:30:01		Wear and Tear Edited on 09/12/2020 17:30:01

Remove cause

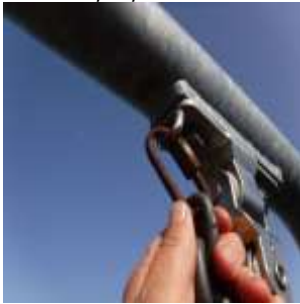
Asset Name	Finding Title	Finding Creation	Resolve By Date	Risk Level	Risk Value	Standard Ref	Cause
1 Bay 1 Basket Seat Swing	Chain - Connectors Notched - (previously reported)	21/09/2020	22/12/2020	Very Low	1 x 3 = 3		Wear and Tear

Replace chain connectors (meeting ISO 1834)

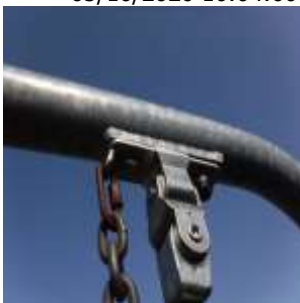
Asset Name	Finding Title	Finding Creation	Resolve By Date	Risk Level	Risk Value	Standard Ref	Cause
1 Bay 1 Basket Seat Swing	Item - Cap(s) missing - (previously reported)	21/09/2020	23/03/2021	Very Low	1 x 1 = 1		Wear and Tear

Standard Description: Cap(s) missing

Replace

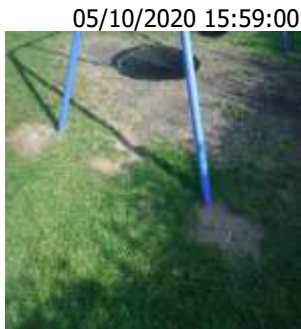
Asset Name	Finding Title	Finding Creation	Resolve By Date	Risk Level	Risk Value	Standard Ref	Cause
1 Bay 1 Basket Seat Swing Surface	Ground Eroded - (previously reported)	21/09/2020	23/03/2021	Very Low	1 x 2 = 2		Wear and Tear

Standard Description: Ground eroded

Make good surface

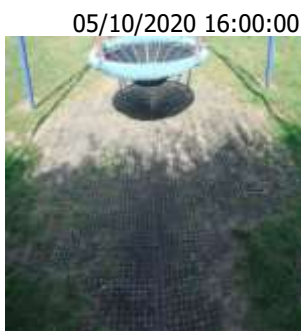
Asset Name	Finding Title	Finding Creation	Resolve By Date	Risk Level	Risk Value	Standard Ref	Cause
1 Bay 1 Basket Seat Swing Surface	Surfacing - Adequate Maintenance - (previously reported)	21/09/2020	21/09/2021	Very Low	1 x 3 = 3	EN 1176:2017 - 1 - 4.2.8.5.2	Wear and Tear

Finding Notes: Matting full of soil/mud

ADVISORY

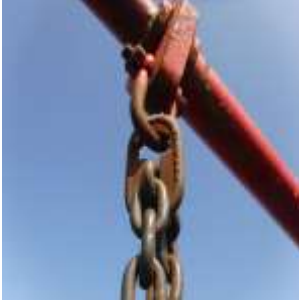
Asset Name	Finding Title	Finding Creation	Resolve By Date	Risk Level	Risk Value	Standard Ref	Cause
1 Bay 2 Cradle Seat Swing	Chain - Cruxiform Connector(s) Worn - (previously reported)	21/09/2020	23/03/2021	Very Low	1 x 3 = 3		Wear and Tear

Standard Description: The cruxiform chain connector is worn.

Replace cruxiform connector(s)

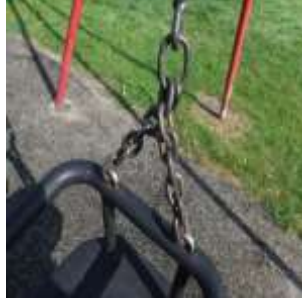
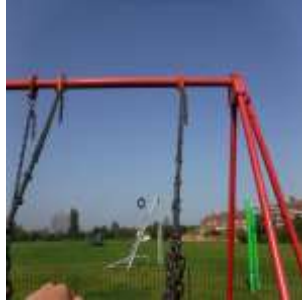
Asset Name	Finding Title	Finding Creation	Resolve By Date	Risk Level	Risk Value	Standard Ref	Cause
1 Bay 2 Cradle Seat Swing	Swing - Chains twisted - (previously reported)	21/09/2020	23/03/2021	Very Low	1 x 1 = 1		Poor Maintenance

Task Title
Refit chains

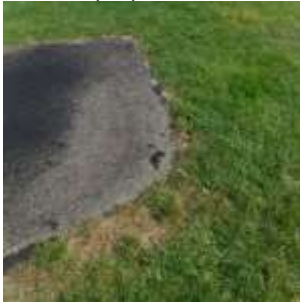
Asset Name	Finding Title	Finding Creation	Resolve By Date	Risk Level	Risk Value	Standard Ref	Cause
1 Bay 2 Cradle Seat Swing Surface	Surface - Grass, Moss or Weeds - (previously reported)	21/09/2020	23/03/2021	Very Low	1 x 3 = 3		Routine

Remove grass, moss & weeds from playing surface

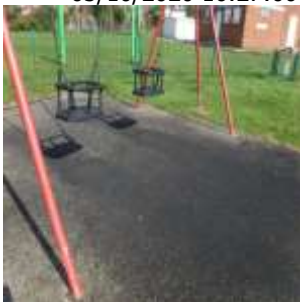
Asset Name	Finding Title	Finding Creation	Resolve By Date	Risk Level	Risk Value	Standard Ref	Cause
1 Bay 2 Cradle Seat Swing Surface	Surface - Wearing - (previously reported)	21/09/2020	21/09/2021	Very Low	1 x 3 = 3		Wear and Tear

Standard Description: Surface wearing

Monitor

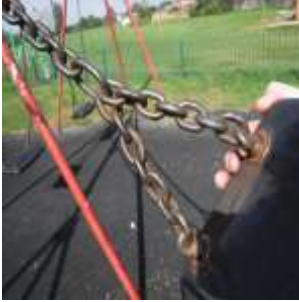
Asset Name	Finding Title	Finding Creation	Resolve By Date	Risk Level	Risk Value	Standard Ref	Cause
2 Bay 4 Flat Seat Swing	Swing - Chains twisted - (previously reported)	21/09/2020	23/03/2021	Very Low	1 x 1 = 1		Poor Maintenance

Refit chains

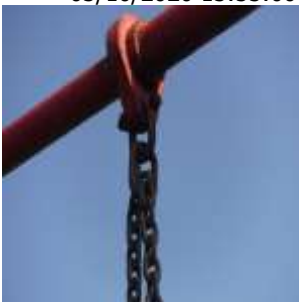
Asset Name	Finding Title	Finding Creation	Resolve By Date	Risk Level	Risk Value	Standard Ref	Cause
2 Bay 4 Flat Seat Swing	Chain - Cruxiform Connector(s) Worn - (previously reported)	21/09/2020	23/03/2021	Very Low	1 x 3 = 3		Wear and Tear

Standard Description: The cruxiform chain connector is worn.

Replace cruxiform connector(s)

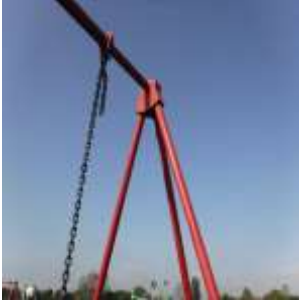
Asset Name	Finding Title	Finding Creation	Resolve By Date	Risk Level	Risk Value	Standard Ref	Cause
2 Bay 4 Flat Seat Swing	Fixtures - Loose or Missing - (previously reported)	21/09/2020	22/12/2020	Low	1 x 4 = 4		Wear and Tear

Standard Description: Fixtures loose or missing

Finding Notes: Headstock loose to legs

Task Title
Tighten loose fixtures & fittings

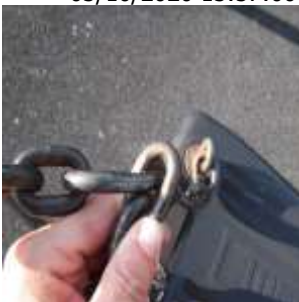
Asset Name	Finding Title	Finding Creation	Resolve By Date	Risk Level	Risk Value	Standard Ref	Cause
2 Bay 4 Flat Seat Swing	Chain - Links Worn - (previously reported)	21/09/2020	21/09/2021	Very Low	1 x 3 = 3		Wear and Tear

Standard Description: Chains links worn

Task Title
Monitor

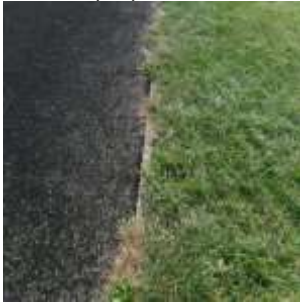
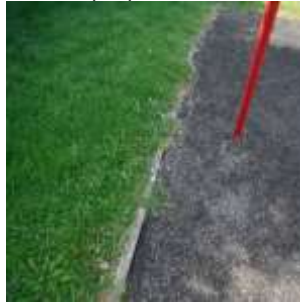
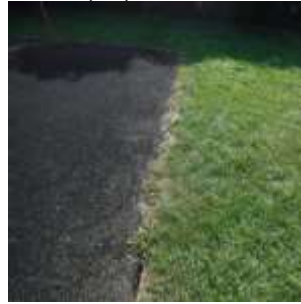
2 Bay 4 Flat Seat Swing Surface Findings

Remove grass, moss & weeds from playing surface

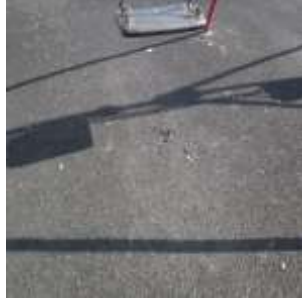
Standard Description: Surface wearing

Monitor

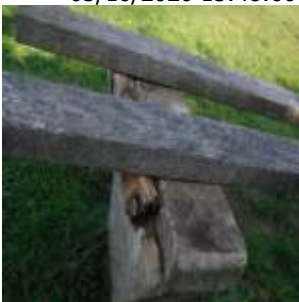
Asset Name	Finding Title	Finding Creation	Resolve By Date	Risk Level	Risk Value	Standard Ref	Cause
Bench x2	Timber - Not in Good Condition - (previously reported)	21/09/2020	21/09/2021	Very Low	1 x 2 = 2		Wear and Tear

Standard Description: Timber condition

Replace damaged wood

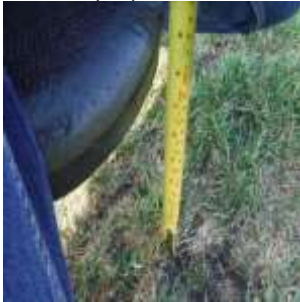
Asset Name	Finding Title	Finding Creation	Resolve By Date	Risk Level	Risk Value	Standard Ref	Cause
Cableway	Falling Space - Extent - End - (previously reported)	21/09/2020	21/10/2020	Medium	3 x 4 = 12	EN 1176:2017 - 4 - 4.14	Wear and Tear

Modify to meet EN 1176

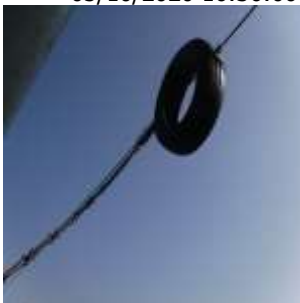
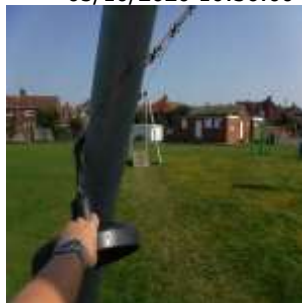
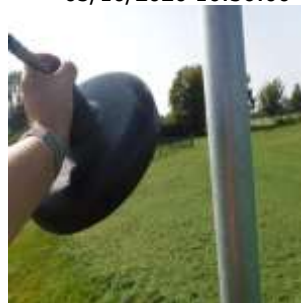
Asset Name	Finding Title	Finding Creation	Resolve By Date	Risk Level	Risk Value	Standard Ref	Cause
Cableway	Brakes Worn - (previously reported)	21/09/2020	22/12/2020	Very Low	1 x 3 = 3		Wear and Tear

Modify to meet EN 1176

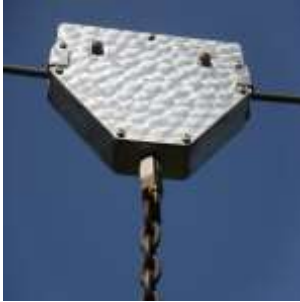
Standard Description: Brakes Worn

Replace item

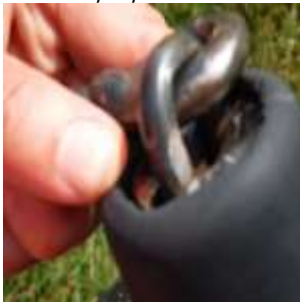
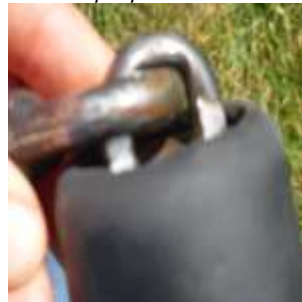
Asset Name	Finding Title	Finding Creation	Resolve By Date	Risk Level	Risk Value	Standard Ref	Cause
Cableway	Chain - Links Worn - (previously reported)	21/09/2020	23/03/2021	Very Low	1 x 3 = 3		Wear and Tear

Standard Description: Chains links worn

Replace chain links (meeting ISO 1834)

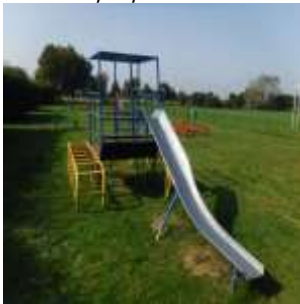
Asset Name	Finding Title	Finding Creation	Resolve By Date	Risk Level	Risk Value	Standard Ref	Cause
Junior Multiplay (Excavator)	EN1176 - Part 1 and Part 3 - Compliance - (previously reported) Edited on 07/10/2020 22:37:14	21/09/2020	21/09/2021	Very Low	1 x 3 = 3	EN 1176:2017 - 1 and EN1176:2017 - 3	Manufacturer Defect

No action required, based on risk assessment, as asset pre-dates EN 1176
