Gordon Playground
Inspections LTD **PSSLive+**

Operational Inspection – December 2020

Churchdown Parish Council

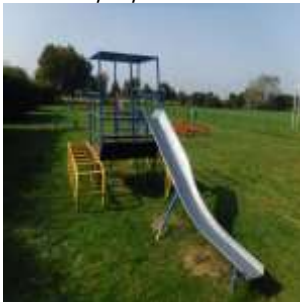
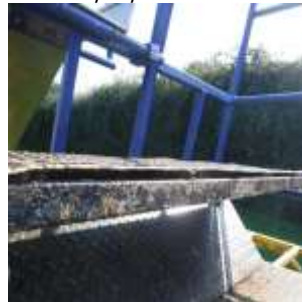
Asset Name	Finding Title	Finding Creation	Resolve By Date	Risk Level	Risk Value	Standard Ref	Cause
Junior Multiplay (Excavator)	Metal - Excessive Corrosion - (previously reported)	21/09/2020	21/09/2021	Very Low	1 x 2 = 2		Wear and Tear

Standard Description: Metal excessive corrosion

Monitor

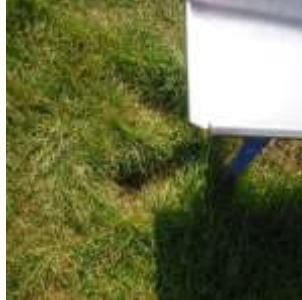
Asset Name	Finding Title	Finding Creation	Resolve By Date	Risk Level	Risk Value	Standard Ref	Cause
Junior Multiplay (Excavator) Surface	Ground Eroded - (previously reported)	21/09/2020	23/03/2021	Very Low	1 x 3 = 3		Wear and Tear

Make good surface

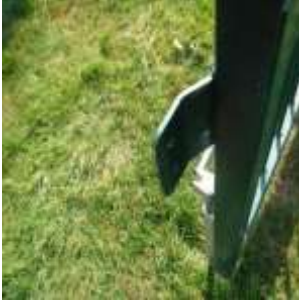
Asset Name	Finding Title	Finding Creation	Resolve By Date	Risk Level	Risk Value	Standard Ref	Cause
Maintenance Gate	Gate - Buffer(s) required - (previously reported)	21/09/2020	23/03/2021	Very Low	1 x 2 = 2		Wear and Tear

Fit buffer(s) to gate

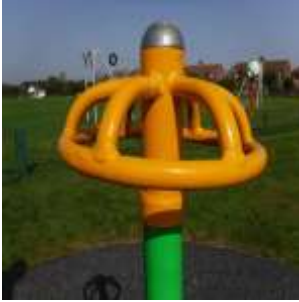
Asset Name	Finding Title	Finding Creation	Resolve By Date	Risk Level	Risk Value	Standard Ref	Cause
Mini Overhead Rotator	Item - Bearings Worn - (previously reported)	21/09/2020	21/09/2021	Very Low	1 x 2 = 2		Wear and Tear

Standard Description: The bearings are worn

Monitor

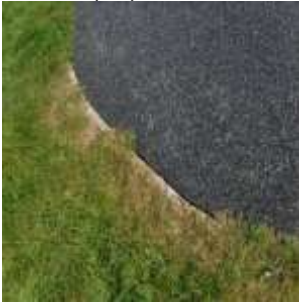
Asset Name	Finding Title	Finding Creation	Resolve By Date	Risk Level	Risk Value	Standard Ref	Cause
Mini Overhead Rotator Surface	Surface - Edges Shrunk - (previously reported)	21/09/2020	21/09/2021	Very Low	1 x 3 = 3		Wear and Tear

Monitor

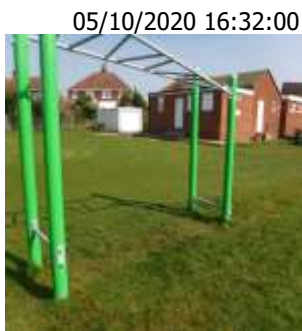
Asset Name	Finding Title	Finding Creation	Resolve By Date	Risk Level	Risk Value	Standard Ref	Cause
Monkey Bars Surface	Surfacing - FHF Over 600mm - Area - (previously reported)	21/09/2020	22/12/2020	Low	2 x 4 = 8	EN 1176:2017 - 1 - 4.2.8.5.2	Installation Defect

Finding Notes: When installed as a piece of play equipment this unit requires a safer surface suitable for the full free height of fall for the unit. Whilst there is grass matting under the unit, it is not believed that the extent is sufficient.

Modify to meet EN 1176

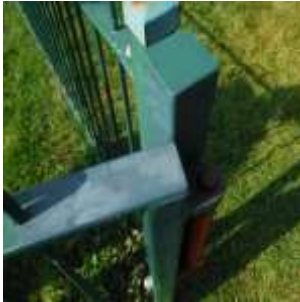
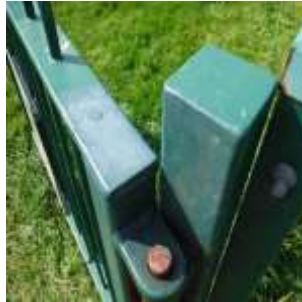
Asset Name	Finding Title	Finding Creation	Resolve By Date	Risk Level	Risk Value	Standard Ref	Cause
Pedestrian Gate x2	Entrapment - Finger - Variable Gaps - (previously reported)	21/09/2020	22/12/2020	Low	1 x 4 = 4	EN 1176:2017 - 1 - 4.2.7.6	Manufacturer Defect

Modify to meet EN 1176

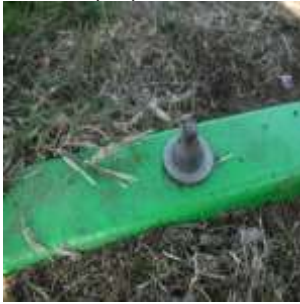
Asset Name	Finding Title	Finding Creation	Resolve By Date	Risk Level	Risk Value	Standard Ref	Cause
Picnic Table	Finish - Bolts Protruding - (previously reported)	21/09/2020	22/12/2020	Low	2 x 2 = 4	EN 1176:2017 - 1 - 4.2.5	Installation Defect

Remove excessive threads

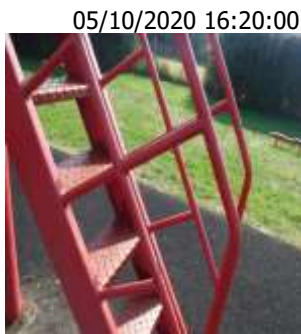
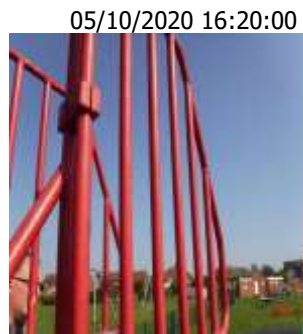
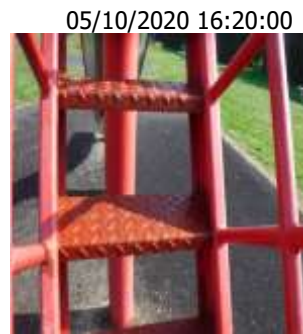
Standard Description: The equipment does not comply with one or more requirements of EN 1176:2017 Part 1.

No action required, based on risk assessment, as asset pre-dates EN 1176

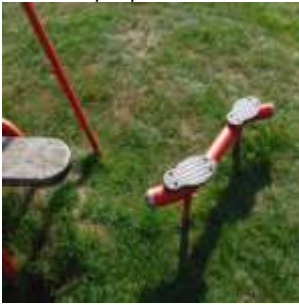
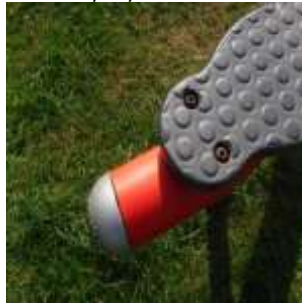
Asset Name	Finding Title	Finding Creation	Resolve By Date	Risk Level	Risk Value	Standard Ref	Cause
Trim Trail	Fixtures - Loose or Missing - (previously reported)	21/09/2020	22/12/2020	Very Low	1 x 3 = 3		Wear and Tear

Standard Description: Fixtures loose or missing

Tighten loose fixtures & fittings

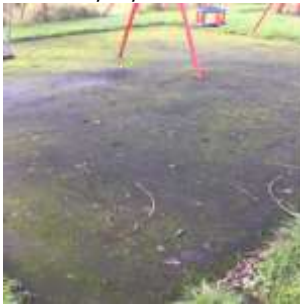
08/12/2020 11:43:00

Asset Name	Finding Title	Finding Creation	Resolve By Date	Risk Level	Risk Value	Standard Ref	Cause
2 Bay 4 Cradle Seat Swing Surface	Autumn leaves need lifting - (previously reported)	08/12/2020	10/03/2021	Very Low	1 x 2 = 2		Routine

Site - Lift autumn leaves

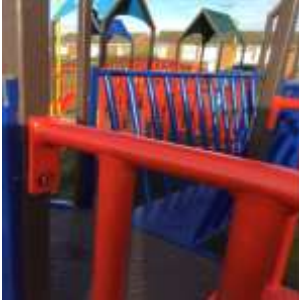
08/12/2020 11:39:00

Asset Name	Finding Title	Finding Creation	Resolve By Date	Risk Level	Risk Value	Standard Ref	Cause
Toddler Multiplay	Fixtures - Loose or Missing - (previously reported)	08/12/2020	10/03/2021	Very Low	1 x 3 = 3		Wear and Tear

Standard Description: Fixtures loose or missing

Tighten loose fixtures & fittings

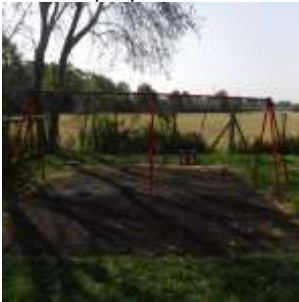
11/10/2020 17:42:00

Asset Name	Finding Title	Finding Creation	Resolve By Date	Risk Level	Risk Value	Standard Ref	Cause
2 Bay 4 Cradle Seat Swing	Swing - Seats - Missing - (previously reported)	21/09/2020	23/03/2021	Very Low	1 x 1 = 1		Routine

Standard Description: Swing seats missing

No action given the risk assessment

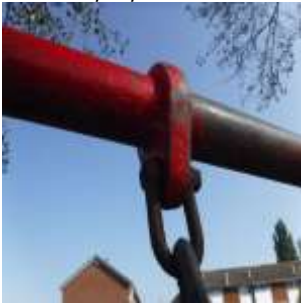
11/10/2020 17:46:00

Asset Name	Finding Title	Finding Creation	Resolve By Date	Risk Level	Risk Value	Standard Ref	Cause
2 Bay 4 Cradle Seat Swing	Swing - Shackles Bushes - Servicing - (previously reported)	21/09/2020	23/03/2021	Very Low	1 x 3 = 3		Wear and Tear

Service shackles and bushes

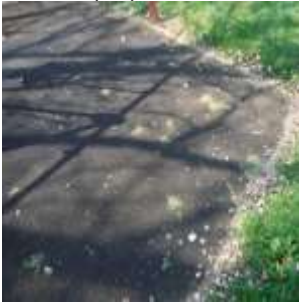
11/10/2020 17:39:00

Asset Name	Finding Title	Finding Creation	Resolve By Date	Risk Level	Risk Value	Standard Ref	Cause
2 Bay 4 Cradle Seat Swing Surface	Surface - Weeds - (previously reported)	21/09/2020	23/03/2021	Very Low	1 x 3 = 3		Routine

Remove weeds

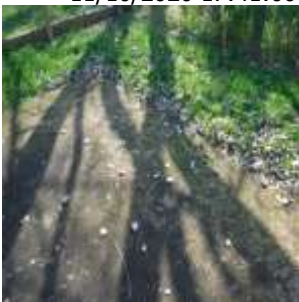
11/10/2020 17:41:00

Asset Name	Finding Title	Finding Creation	Resolve By Date	Risk Level	Risk Value	Standard Ref	Cause
2 Bay 4 Cradle Seat Swing Surface	Surface - Moss - (previously reported)	21/09/2020	22/12/2020	Low	2 x 3 = 6		Routine

Power Wash

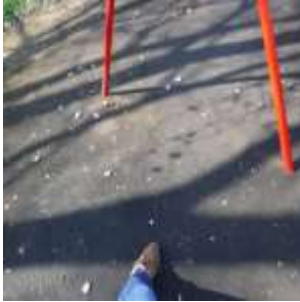
11/10/2020 17:41:00

Asset Name	Finding Title	Finding Creation	Resolve By Date	Risk Level	Risk Value	Standard Ref	Cause
2 Bay 4 Cradle Seat Swing Surface	Surface - Slippery - (previously reported)	21/09/2020	22/12/2020	Low	2 x 3 = 6		Wear and Tear

Task Title
Power Wash

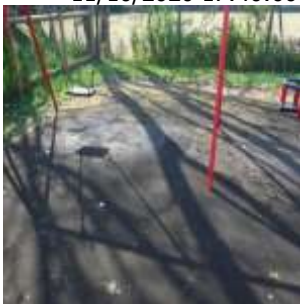
11/10/2020 17:40:00

Asset Name	Finding Title	Finding Creation	Resolve By Date	Risk Level	Risk Value	Standard Ref	Cause
2 Bay 4 Cradle Seat Swing Surface	Surface - Wearing - (previously reported)	21/09/2020	21/09/2021	Very Low	1 x 3 = 3		Wear and Tear

Standard Description: Surface wearing

Task Title
Monitor

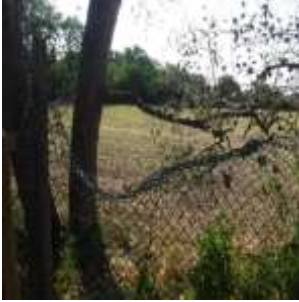
11/10/2020 17:30:00

Asset Name	Finding Title	Finding Creation	Resolve By Date	Risk Level	Risk Value	Standard Ref	Cause
Fence - Chain Link	Fencing - Panel damaged - (previously reported)	21/09/2020	23/03/2021	Very Low	1 x 2 = 2		Wear and Tear

Standard Description: Fencing - Panel damaged

Repair

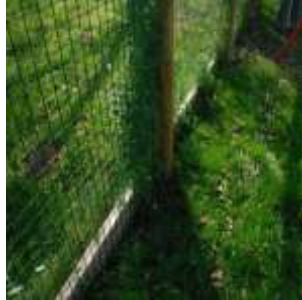
11/10/2020 17:28:00

Asset Name	Finding Title	Finding Creation	Resolve By Date	Risk Level	Risk Value	Standard Ref	Cause
Fence - Post, Rail and Wire Mesh	Item - Loose in Ground - (previously reported)	21/09/2020	21/09/2021	Very Low	1 x 1 = 1		Wear and Tear

Standard Description: Loose in ground

Monitor

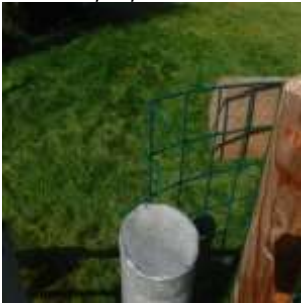
11/10/2020 17:29:00

Asset Name	Finding Title	Finding Creation	Resolve By Date	Risk Level	Risk Value	Standard Ref	Cause
Fence - Post, Rail and Wire Mesh	Item - Hard or Sharp Projections - (previously reported)	21/09/2020	22/12/2020	Low	2 x 2 = 4		Installation Defect

Remove hard, pointed & sharp projections

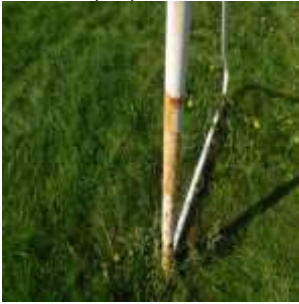
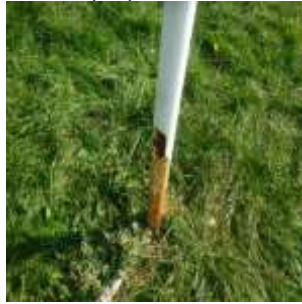
Asset Name	Finding Title	Finding Creation	Resolve By Date	Risk Level	Risk Value	Standard Ref	Cause
Goal Post	Item - Rusting in places - (previously reported)	21/09/2020	23/03/2021	Very Low	1 x 2 = 2		Wear and Tear

Standard Description: Item is rusting in places

De-rust and coat with paint meeting EN 1176 - 4.1.1 [1998]

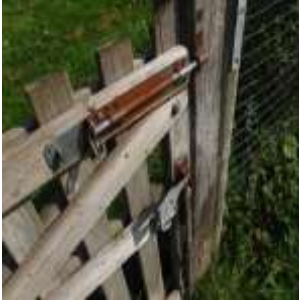
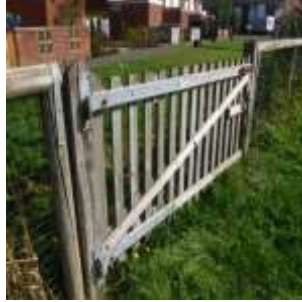
Asset Name	Finding Title	Finding Creation	Resolve By Date	Risk Level	Risk Value	Standard Ref	Cause
Maintenance Gate - Field (Wooden)	Gate - Maintenance - Not Locked - (previously reported)	21/09/2020	21/10/2020	Very Low	1 x 2 = 2		Poor Maintenance

Lock maintenance / vehicle gate

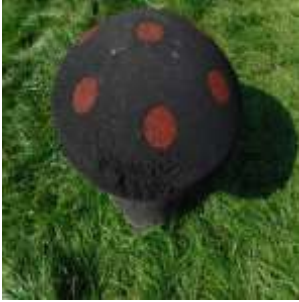
11/10/2020 17:55:00

Asset Name	Finding Title	Finding Creation	Resolve By Date	Risk Level	Risk Value	Standard Ref	Cause
Mushroom x3	Item - Damaged - (previously reported)	21/09/2020	21/09/2021	Very Low	1 x 1 = 1		Wear and Tear

Standard Description: Item is damaged

Monitor

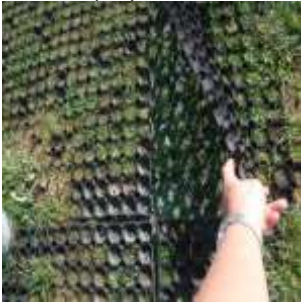
11/10/2020 17:58:00

Asset Name	Finding Title	Finding Creation	Resolve By Date	Risk Level	Risk Value	Standard Ref	Cause
Overhead Rotator Surface	Surface - Needs Repair - (previously reported)	21/09/2020	22/12/2020	Low	2 x 3 = 6		Wear and Tear

Standard Description: Surface needs repair

Repair surface

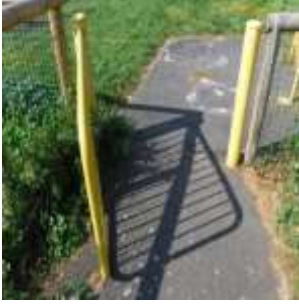
11/10/2020 17:33:00

Asset Name	Finding Title	Finding Creation	Resolve By Date	Risk Level	Risk Value	Standard Ref	Cause
Pedestrian Gate - Field	Gate - Self-Closing - Adjustment - (previously reported)	21/09/2020	22/12/2020	Very Low	1 x 3 = 3		Wear and Tear

Adjust self-closure mechanism

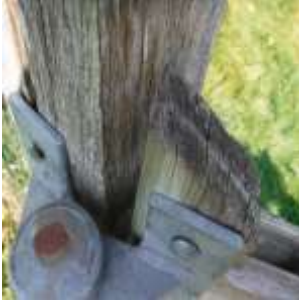
11/10/2020 18:04:00

Asset Name	Finding Title	Finding Creation	Resolve By Date	Risk Level	Risk Value	Standard Ref	Cause
Pedestrian Gate - Field (Wooden)	Entrapment - Finger - Variable Gaps - (previously reported)	21/09/2020	22/12/2020	Low	1 x 4 = 4	EN 1176:2017 - 1 - 4.2.7.6	Wear and Tear

Modify to meet EN 1176

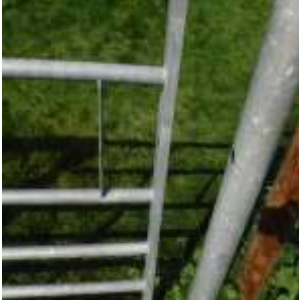
11/10/2020 17:38:00

Standard Description: Item has some parts missing

Replace missing parts

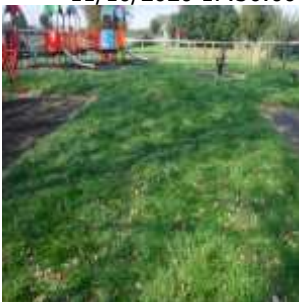
11/10/2020 17:36:00

Asset Name	Finding Title	Finding Creation	Resolve By Date	Risk Level	Risk Value	Standard Ref	Cause
Site - Oakhurst Play Area	Grass - Requires Mowing/Cutting - (previously reported)	21/09/2020	21/10/2020	Very Low	1 x 3 = 3		Routine

Task Title
Cut/Mow Grass

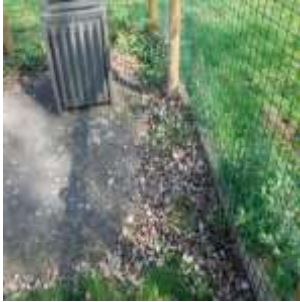
11/10/2020 17:36:00

Asset Name	Finding Title	Finding Creation	Resolve By Date	Risk Level	Risk Value	Standard Ref	Cause
Site - Oakhurst Play Area	Autumn leaves need lifting - (previously reported)	21/09/2020	22/12/2020	Very Low	1 x 2 = 2		Routine

Task Title
Site - Lift autumn leaves

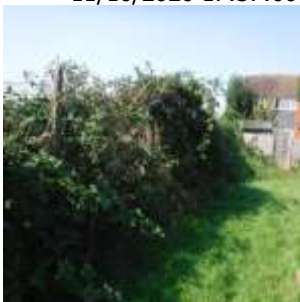
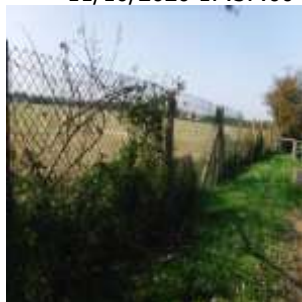
Asset Name	Finding Title	Finding Creation	Resolve By Date	Risk Level	Risk Value	Standard Ref	Cause
Site - Oakhurst Play Area	Surface - Encroaching vegetation/trees - (previously reported)	21/09/2020	22/12/2020	Low	2 x 2 = 4		Routine

Task Title
Cut back vegetation/trees

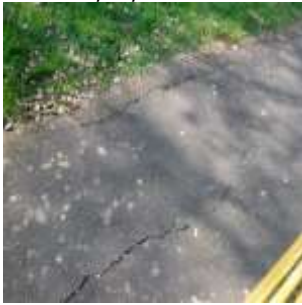
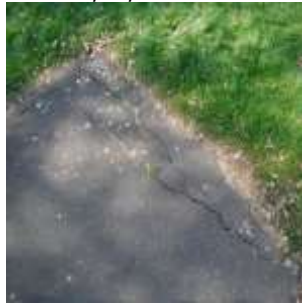
Asset Name	Finding Title	Finding Creation	Resolve By Date	Risk Level	Risk Value	Standard Ref	Cause
Site - Oakhurst Play Area	Surface - Needs Repair - (previously reported)	21/09/2020	23/03/2021	Very Low	1 x 3 = 3		Wear and Tear

Task Title
Repair surface

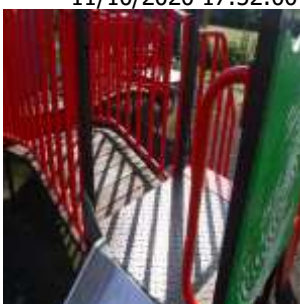
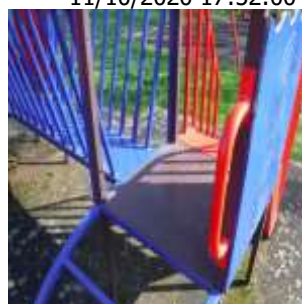
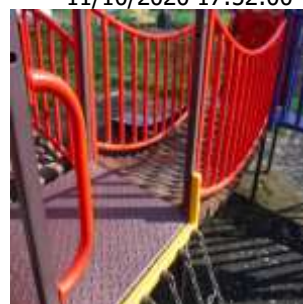
Asset Name	Finding Title	Finding Creation	Resolve By Date	Risk Level	Risk Value	Standard Ref	Cause
Toddler Multiplay	Item - Parts Missing - (previously reported)	21/09/2020	23/03/2021	Very Low	1 x 3 = 3		Wear and Tear

Standard Description: Item has some parts missing

Replace missing parts

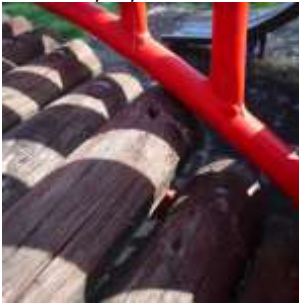
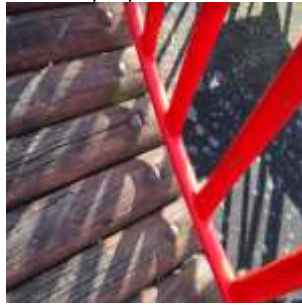
Asset Name	Finding Title	Finding Creation	Resolve By Date	Risk Level	Risk Value	Standard Ref	Cause
Toddler Multiplay	Fixtures - Loose or Missing - (previously reported)	21/09/2020	22/12/2020	Very Low	1 x 3 = 3		Wear and Tear

Standard Description: Fixtures loose or missing

Task Title
Replace missing fasteners, fixtures and fitting

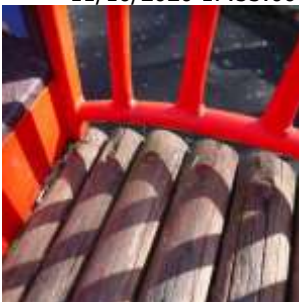
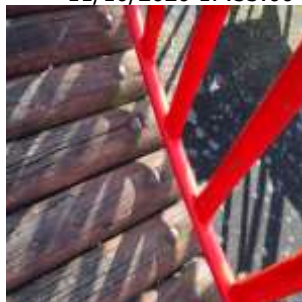
Asset Name	Finding Title	Finding Creation	Resolve By Date	Risk Level	Risk Value	Standard Ref	Cause
Toddler Multiplay	Fixtures - Loose or Missing - (previously reported)	21/09/2020	23/03/2021	Very Low	1 x 2 = 2		Wear and Tear

Standard Description: Fixtures loose or missing

Task Title
Tighten loose fixtures & fittings

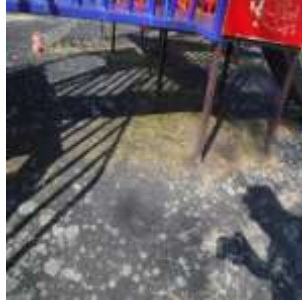
Asset Name	Finding Title	Finding Creation	Resolve By Date	Risk Level	Risk Value	Standard Ref	Cause
Toddler Multiplay Surface	Surface - Moss - (previously reported)	21/09/2020	22/12/2020	Low	2 x 3 = 6		Routine

Power Wash

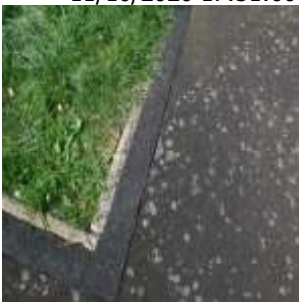
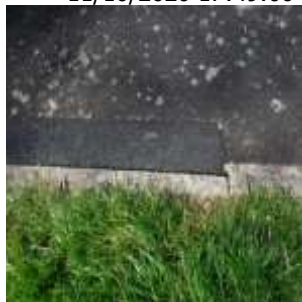
Asset Name	Finding Title	Finding Creation	Resolve By Date	Risk Level	Risk Value	Standard Ref	Cause
Toddler Multiplay Surface	Surface - Edges Shrunk - (previously reported)	21/09/2020	21/09/2021	Very Low	1 x 1 = 1		Wear and Tear

Monitor

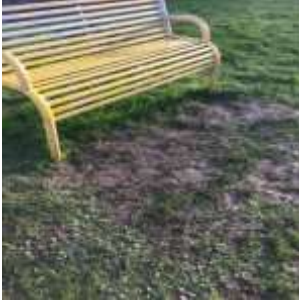
Asset Name	Finding Title	Finding Creation	Resolve By Date	Risk Level	Risk Value	Standard Ref	Cause
Seat x2	Ground Eroded - (previously reported)	08/12/2020	09/06/2021	Very Low	1 x 3 = 3		Wear and Tear

Make good surface

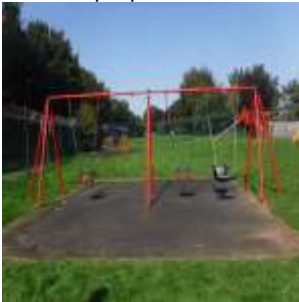
Asset Name	Finding Title	Finding Creation	Resolve By Date	Risk Level	Risk Value	Standard Ref	Cause
2 Bay 3 Cradle 1 Tango Seat Swing	Swing - Seats - Missing - (previously reported)	21/09/2020	23/03/2021	Very Low	1 x 1 = 1		Routine

Standard Description: Swing seats missing

No action given the risk assessment

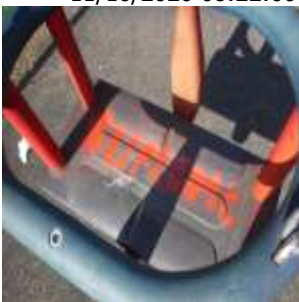
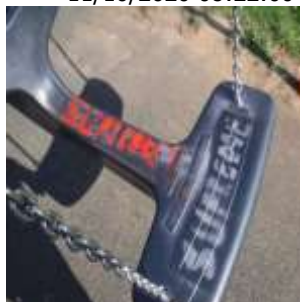
Asset Name	Finding Title	Finding Creation	Resolve By Date	Risk Level	Risk Value	Standard Ref	Cause
2 Bay 3 Cradle 1 Tango Seat Swing	Item - Graffiti - Present - (previously reported)	21/09/2020	23/03/2021	Very Low	1 x 1 = 1		Vandalism

Remove graffiti

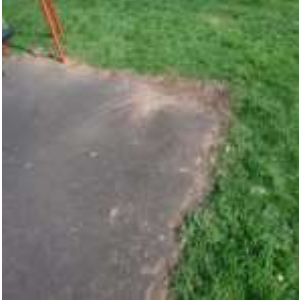
Asset Name	Finding Title	Finding Creation	Resolve By Date	Risk Level	Risk Value	Standard Ref	Cause
2 Bay 3 Cradle 1 Tango Seat Swing Surface	Surface - Grass, Moss or Weeds - (previously reported)	21/09/2020	23/03/2021	Very Low	1 x 3 = 3		Routine

Remove grass, moss & weeds from playing surface

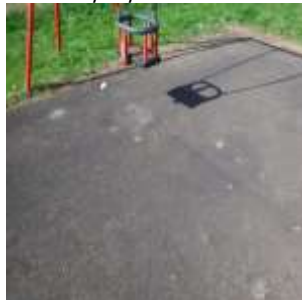
Asset Name	Finding Title	Finding Creation	Resolve By Date	Risk Level	Risk Value	Standard Ref	Cause
2 Bay 3 Cradle 1 Tango Seat Swing Surface	Surface - Wearing - (previously reported)	21/09/2020	21/09/2021	Very Low	1 x 2 = 2		Wear and Tear

Standard Description: Surface wearing

Monitor

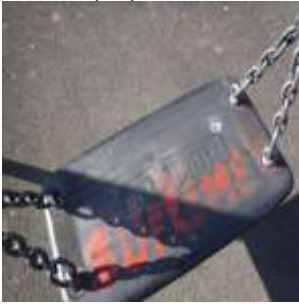
Asset Name	Finding Title	Finding Creation	Resolve By Date	Risk Level	Risk Value	Standard Ref	Cause
2 Bay 4 Flat Seat Swing	Item - Graffiti - Present - (previously reported)	21/09/2020	23/03/2021	Very Low	1 x 1 = 1		Vandalism

Task Title
Remove graffiti

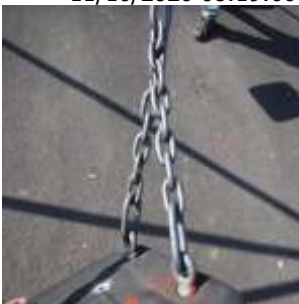
Asset Name	Finding Title	Finding Creation	Resolve By Date	Risk Level	Risk Value	Standard Ref	Cause
2 Bay 4 Flat Seat Swing	Swing - Chains twisted - (previously reported)	21/09/2020	23/03/2021	Very Low	1 x 1 = 1		Poor Maintenance

Task Title
Refit chains

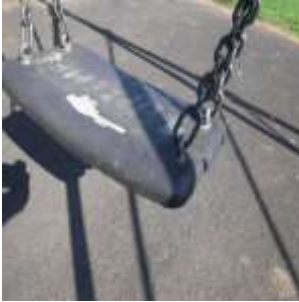
Asset Name	Finding Title	Finding Creation	Resolve By Date	Risk Level	Risk Value	Standard Ref	Cause
2 Bay 4 Flat Seat Swing	Swing - Seat(s) - Damaged - (previously reported)	21/09/2020	21/09/2021	Very Low	1 x 2 = 2		Wear and Tear

Standard Description: Swing seat damaged

Monitor

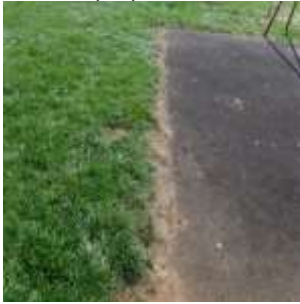
Asset Name	Finding Title	Finding Creation	Resolve By Date	Risk Level	Risk Value	Standard Ref	Cause
2 Bay 4 Flat Seat Swing Surface	Surface - Grass, Moss or Weeds - (previously reported)	21/09/2020	23/03/2021	Very Low	1 x 3 = 3		Routine

Remove grass, moss & weeds from playing surface

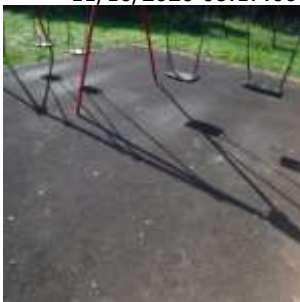
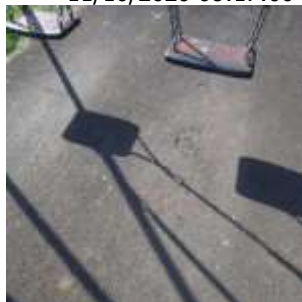
Asset Name	Finding Title	Finding Creation	Resolve By Date	Risk Level	Risk Value	Standard Ref	Cause
2 Bay 4 Flat Seat Swing Surface	Surface - Wearing - (previously reported)	21/09/2020	21/09/2021	Very Low	1 x 3 = 3		Wear and Tear

Standard Description: Surface wearing

Monitor

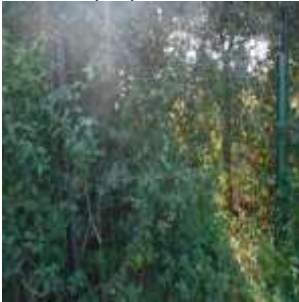
Asset Name	Finding Title	Finding Creation	Resolve By Date	Risk Level	Risk Value	Standard Ref	Cause
Fence	Fencing - Panel damaged - (previously reported)	21/09/2020	23/03/2021	Very Low	1 x 3 = 3		Wear and Tear

Standard Description: Fencing - Panel damaged

Task Title
Replace

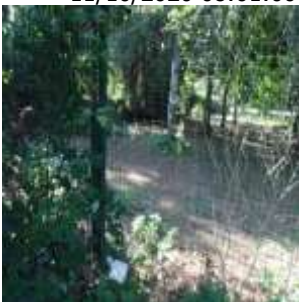
Asset Name	Finding Title	Finding Creation	Resolve By Date	Risk Level	Risk Value	Standard Ref	Cause
Fence	Item - Damaged - (previously reported)	21/09/2020	23/03/2021	Very Low	1 x 2 = 2		Wear and Tear

Standard Description: Item is damaged

Task Title
Repair item

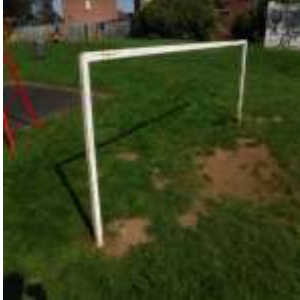
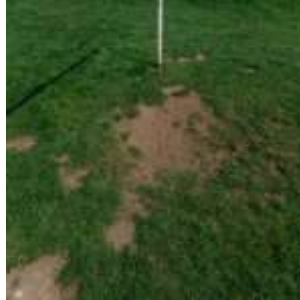
Asset Name	Finding Title	Finding Creation	Resolve By Date	Risk Level	Risk Value	Standard Ref	Cause
Goal Post	Ground Eroded - (previously reported)	21/09/2020	23/03/2021	Very Low	1 x 3 = 3		Wear and Tear

Make good surface

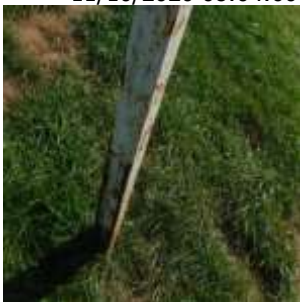
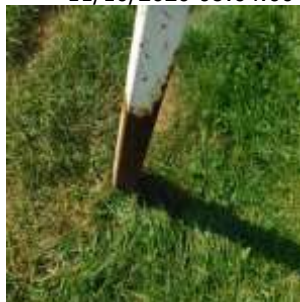
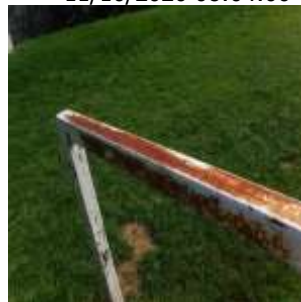
Asset Name	Finding Title	Finding Creation	Resolve By Date	Risk Level	Risk Value	Standard Ref	Cause
Goal Post	Item - Rusting in places - (previously reported)	21/09/2020	23/03/2021	Very Low	1 x 1 = 1		Wear and Tear

Standard Description: Item is rusting in places

De-rust and coat with paint meeting EN 1176 - 4.1.1 [1998]

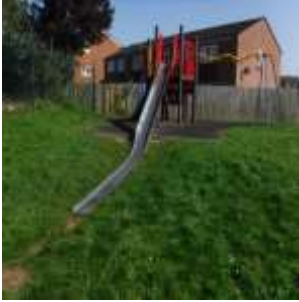
Asset Name	Finding Title	Finding Creation	Resolve By Date	Risk Level	Risk Value	Standard Ref	Cause
Junior Multiplay	EN1176:2017 - Part 1 - Compliance - (previously reported)	21/09/2020	21/09/2021	Very Low	1 x 3 = 3	EN 1176:2017 - 1	Manufacturer Defect

No action required, based on risk assessment, as asset pre-dates EN 1176

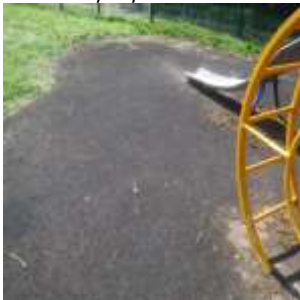
Standard Description: Surface wearing

Monitor

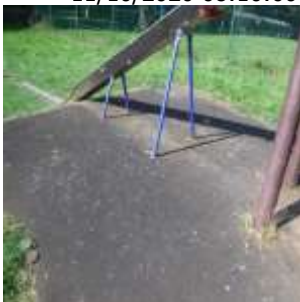
Asset Name	Finding Title	Finding Creation	Resolve By Date	Risk Level	Risk Value	Standard Ref	Cause
Junior Multiplay Surface	Surface - Wearing - (previously reported)	21/09/2020	21/09/2021	Very Low	1 x 2 = 2		Wear and Tear

Standard Description: Surface wearing

Monitor

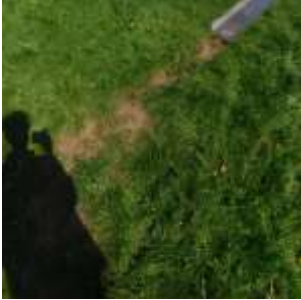
Asset Name	Finding Title	Finding Creation	Resolve By Date	Risk Level	Risk Value	Standard Ref	Cause
Junior Multiplay Surface	Ground Eroded - (previously reported)	21/09/2020	23/03/2021	Very Low	1 x 3 = 3		Wear and Tear

Make good surface

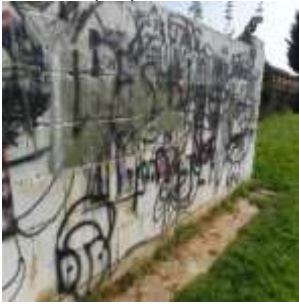
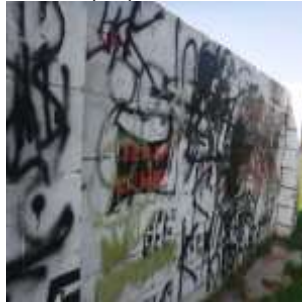
Asset Name	Finding Title	Finding Creation	Resolve By Date	Risk Level	Risk Value	Standard Ref	Cause
Kickwall	Item - Graffiti - Present - (previously reported)	21/09/2020	23/03/2021	Very Low	1 x 1 = 1		Vandalism

Remove graffiti

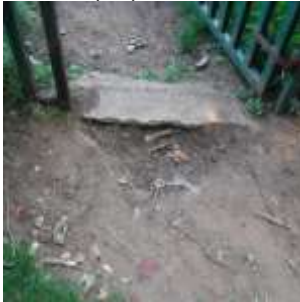
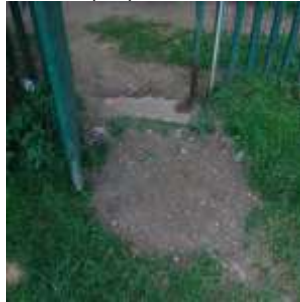
Asset Name	Finding Title	Finding Creation	Resolve By Date	Risk Level	Risk Value	Standard Ref	Cause
Pedestrian Gate	Surface - Trip points - (previously reported)	21/09/2020	22/12/2020	Low	3 x 3 = 9		Wear and Tear

Repair surface

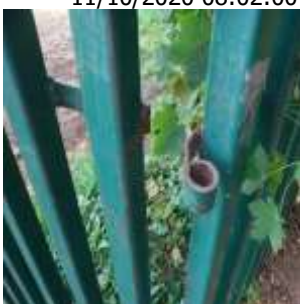
Asset Name	Finding Title	Finding Creation	Resolve By Date	Risk Level	Risk Value	Standard Ref	Cause
Pedestrian Gate	Metal - Welds are Cracked - (previously reported)	21/09/2020	23/03/2021	Very Low	1 x 3 = 3		Wear and Tear

Standard Description: Metal weld cracks

Reweld

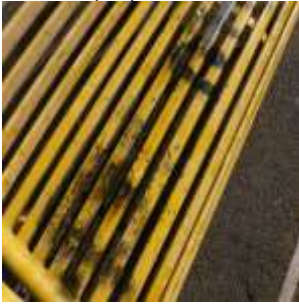
Asset Name	Finding Title	Finding Creation	Resolve By Date	Risk Level	Risk Value	Standard Ref	Cause
Seat x2	Item - Graffiti - Present - (previously reported)	21/09/2020	23/03/2021	Very Low	1 x 1 = 1		Vandalism

Remove graffiti

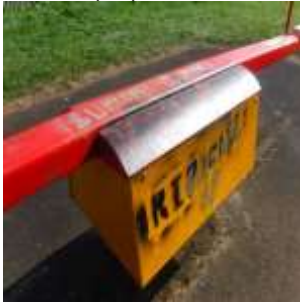
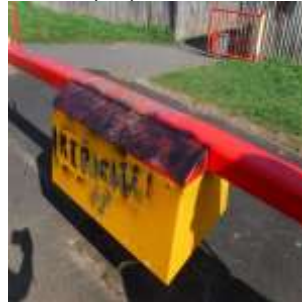
Asset Name	Finding Title	Finding Creation	Resolve By Date	Risk Level	Risk Value	Standard Ref	Cause
Seesaw	Item - Graffiti - Present - (previously reported)	21/09/2020	23/03/2021	Very Low	1 x 1 = 1		Vandalism

Remove graffiti

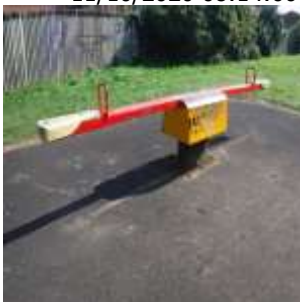
Asset Name	Finding Title	Finding Creation	Resolve By Date	Risk Level	Risk Value	Standard Ref	Cause
Seesaw	EN1176 - Part 1 and Part 6 - Compliance - (previously reported)	21/09/2020	21/09/2021	Very Low	1 x 3 = 3	EN 1176:2017 - 1 and EN 1176:2017 - 6	Manufacturer Defect

No action required, based on risk assessment, as asset pre-dates EN 1176

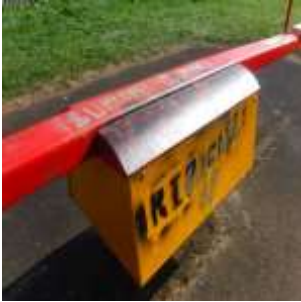
Asset Name	Finding Title	Finding Creation	Resolve By Date	Risk Level	Risk Value	Standard Ref	Cause
Seesaw	Item - Bearings Worn - (previously reported)	21/09/2020	21/09/2021	Very Low	1 x 1 = 1		Wear and Tear

Standard Description: The bearings are worn

Task Title
Monitor

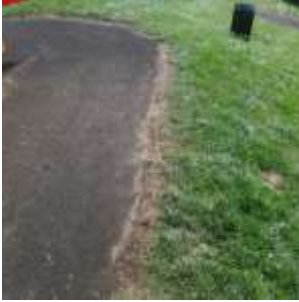
Asset Name	Finding Title	Finding Creation	Resolve By Date	Risk Level	Risk Value	Standard Ref	Cause
Seesaw Surface	Surface - Grass, Moss or Weeds - (previously reported)	21/09/2020	23/03/2021	Very Low	1 x 3 = 3		Routine

Remove grass, moss & weeds from playing surface

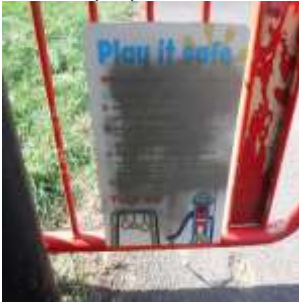
Asset Name	Finding Title	Finding Creation	Resolve By Date	Risk Level	Risk Value	Standard Ref	Cause
Signage	Item - Graffiti - Present - (previously reported)	21/09/2020	23/03/2021	Very Low	1 x 1 = 1		Vandalism

Remove graffiti

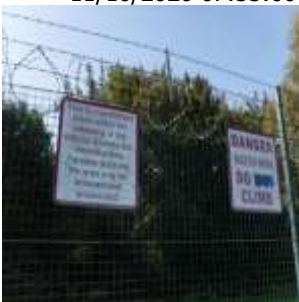
Asset Name	Finding Title	Finding Creation	Resolve By Date	Risk Level	Risk Value	Standard Ref	Cause
Signage	Item - Graffiti - Present - (previously reported)	21/09/2020	22/12/2020	Very Low	1 x 1 = 1		Vandalism

Remove graffiti

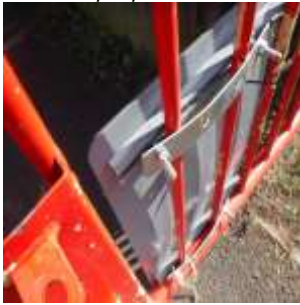
Asset Name	Finding Title	Finding Creation	Resolve By Date	Risk Level	Risk Value	Standard Ref	Cause
Signage	Finish - Bolts Protruding - (previously reported)	21/09/2020	22/12/2020	Low	2 x 2 = 4	EN 1176:2017 - 1 - 4.2.5	Installation Defect

Task Title
Remove excessive threads

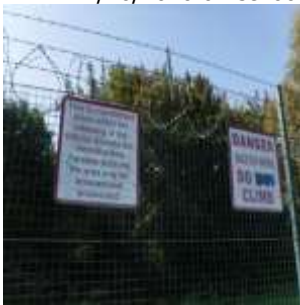
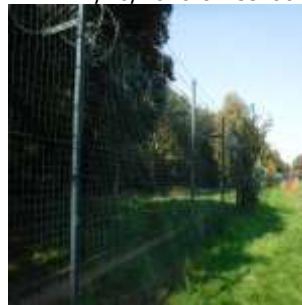
Asset Name	Finding Title	Finding Creation	Resolve By Date	Risk Level	Risk Value	Standard Ref	Cause
Site - Shamrock Close Play Area	Other / Miscellaneous - (previously reported)	21/09/2020	21/09/2021	Very Low	1 x 3 = 3		Other - See Finding Notes

Task Title
Monitor

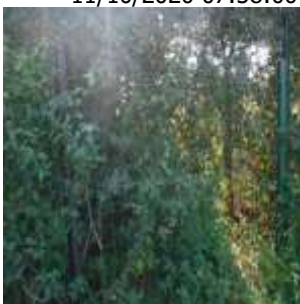
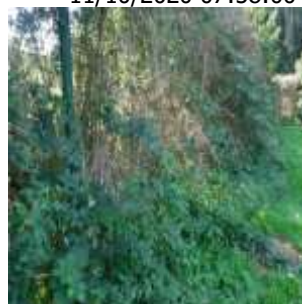
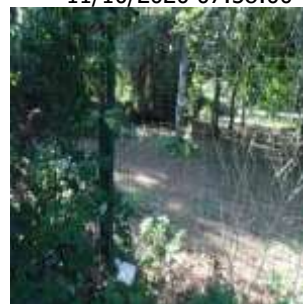
Asset Name	Finding Title	Finding Creation	Resolve By Date	Risk Level	Risk Value	Standard Ref	Cause
Site - Shamrock Close Play Area	Surface - Encroaching vegetation/trees - (previously reported)	21/09/2020	22/12/2020	Low	2 x 2 = 4		Routine

Task Title
Cut back vegetation/trees

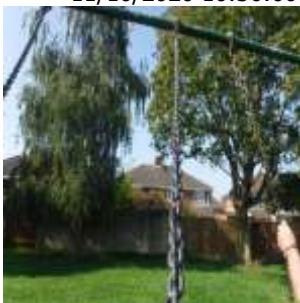
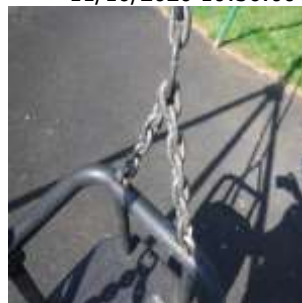
Asset Name	Finding Title	Finding Creation	Resolve By Date	Risk Level	Risk Value	Standard Ref	Cause
1 Bay 2 Cradle Seat Swing	EN1176:2017 - Part 2 - Compliance - (previously reported)	21/09/2020	21/09/2021	Very Low	1 x 3 = 3	EN 1176:2017 - 2	Manufacturer Defect

Task Title
Refit chains

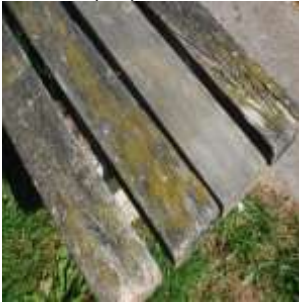
Asset Name	Finding Title	Finding Creation	Resolve By Date	Risk Level	Risk Value	Standard Ref	Cause
Bench x5	Timber - Not in Good Condition - (previously reported)	21/09/2020	21/09/2021	Very Low	1 x 2 = 2		Wear and Tear

Standard Description: Timber condition

Monitor

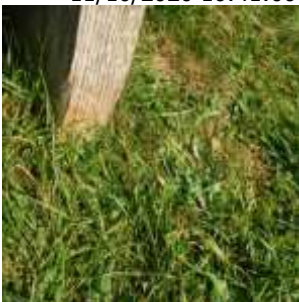
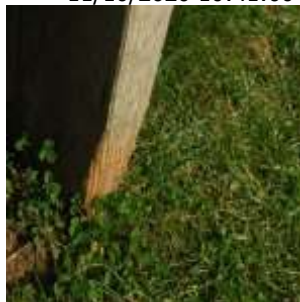
Asset Name	Finding Title	Finding Creation	Resolve By Date	Risk Level	Risk Value	Standard Ref	Cause
Bench x5	Timber - Strimmer Damage - (previously reported)	21/09/2020	23/03/2021	Very Low	1 x 1 = 1		Poor Maintenance

Standard Description: The timber has been damaged during grass cutting works.

Notify grounds maintenance staff

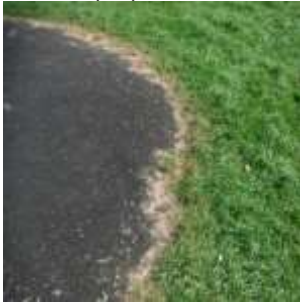
Asset Name	Finding Title	Finding Creation	Resolve By Date	Risk Level	Risk Value	Standard Ref	Cause
Carousel Surface	Surface - Grass, Moss or Weeds - (previously reported)	21/09/2020	23/03/2021	Very Low	1 x 3 = 3		Routine

Remove grass, moss & weeds from playing surface

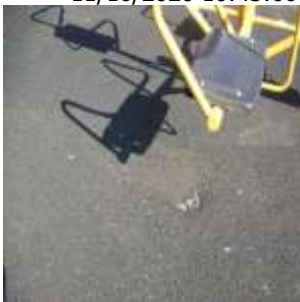
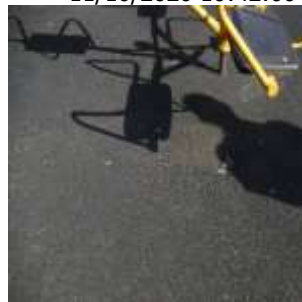
Asset Name	Finding Title	Finding Creation	Resolve By Date	Risk Level	Risk Value	Standard Ref	Cause
Carousel Surface	Surface - Needs Repair - (previously reported)	21/09/2020	21/09/2021	Low	2 x 3 = 6		Wear and Tear

Standard Description: Surface needs repair

Repair surface

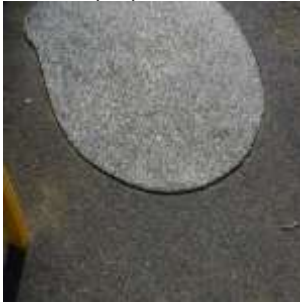
Asset Name	Finding Title	Finding Creation	Resolve By Date	Risk Level	Risk Value	Standard Ref	Cause
Dome Climber Surface	Surface - Edges Shrunk - (previously reported)	21/09/2020	23/03/2021	Very Low	1 x 3 = 3		Wear and Tear

Task Title
Repair edges

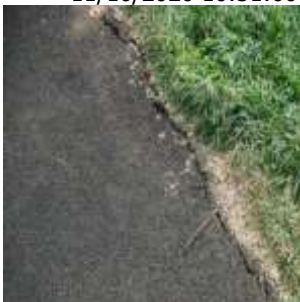
Asset Name	Finding Title	Finding Creation	Resolve By Date	Risk Level	Risk Value	Standard Ref	Cause
Dome Climber Surface	Surface - Cracking - (previously reported)	21/09/2020	21/09/2021	Very Low	1 x 2 = 2		Wear and Tear

Task Title
Monitor

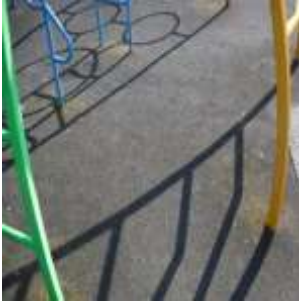
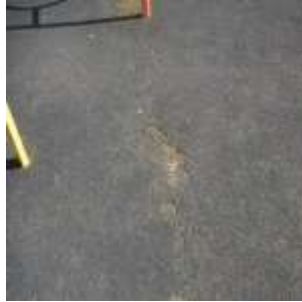
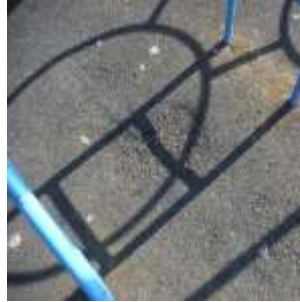
Asset Name	Finding Title	Finding Creation	Resolve By Date	Risk Level	Risk Value	Standard Ref	Cause
Dome Climber Surface	Surface - Wearing - (previously reported)	21/09/2020	23/03/2021	Very Low	1 x 3 = 3		Wear and Tear

Standard Description: Surface wearing

Repair surface

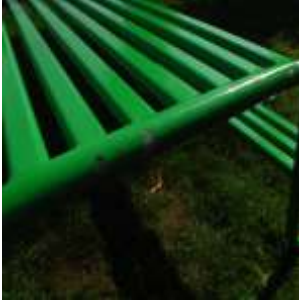
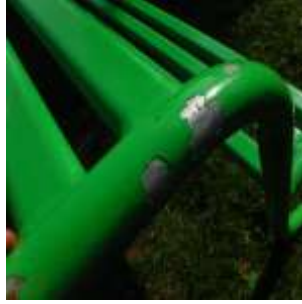
Asset Name	Finding Title	Finding Creation	Resolve By Date	Risk Level	Risk Value	Standard Ref	Cause
Picnic Table	Metal - Paint-work - Not in Good Condition - (previously reported)	21/09/2020	23/03/2021	Very Low	1 x 2 = 2		Wear and Tear

Standard Description: Metal paint-work condition

Repair damaged area(s)

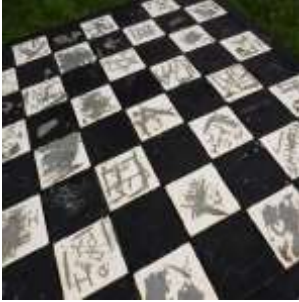
Asset Name	Finding Title	Finding Creation	Resolve By Date	Risk Level	Risk Value	Standard Ref	Cause
Picnic Table (Chess)	Metal - Paint-work - Not in Good Condition - (previously reported)	21/09/2020	23/03/2021	Very Low	1 x 2 = 2		Wear and Tear

Standard Description: Metal paint-work condition

De-rust and coat with paint meeting EN 1176 - 4.1.1 [1998]

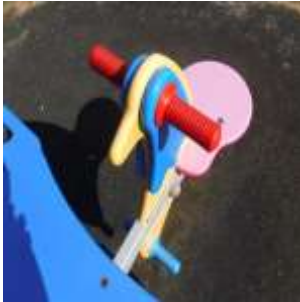
Asset Name	Finding Title	Finding Creation	Resolve By Date	Risk Level	Risk Value	Standard Ref	Cause
Rocker Seesaw	Hand Supports and Foot Rests - Shape - (previously reported)	21/09/2020	21/09/2021	Very Low	1 x 3 = 3	EN 1176:2017 - 6 - 4.6 and 4.7	Manufacturer Defect

No action required, based on risk assessment, as asset pre-dates EN 1176

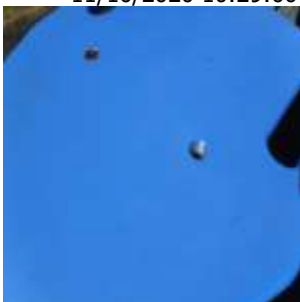
Asset Name	Finding Title	Finding Creation	Resolve By Date	Risk Level	Risk Value	Standard Ref	Cause
Rocker Seesaw	Fixtures - Loose or Missing - (previously reported)	21/09/2020	23/03/2021	Very Low	1 x 2 = 2		Wear and Tear

Standard Description: Fixtures loose or missing

Replace missing fasteners, fixtures and fitting

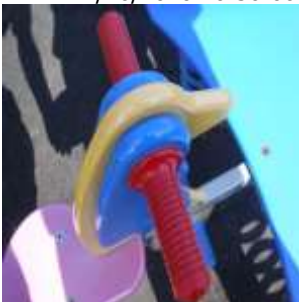
Asset Name	Finding Title	Finding Creation	Resolve By Date	Risk Level	Risk Value	Standard Ref	Cause
Rocker Seesaw	Fixtures - Loose or Missing - (previously reported)	21/09/2020	23/03/2021	Very Low	1 x 3 = 3		Wear and Tear

Standard Description: Fixtures loose or missing

Tighten loose fixtures & fittings

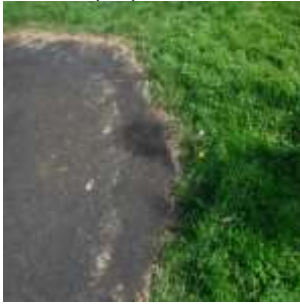
Asset Name	Finding Title	Finding Creation	Resolve By Date	Risk Level	Risk Value	Standard Ref	Cause
Rocker Seesaw Surface	Surface - Grass, Moss or Weeds - (previously reported)	21/09/2020	23/03/2021	Very Low	1 x 3 = 3		Routine

Remove grass, moss & weeds from playing surface

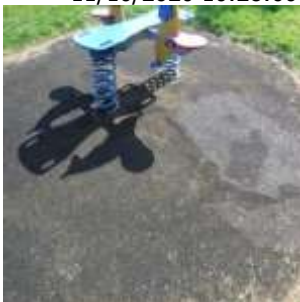
Asset Name	Finding Title	Finding Creation	Resolve By Date	Risk Level	Risk Value	Standard Ref	Cause
Rocker Seesaw Surface	Surface - Wearing - (previously reported)	21/09/2020	21/09/2021	Very Low	1 x 3 = 3		Wear and Tear

Standard Description: Surface wearing

Monitor

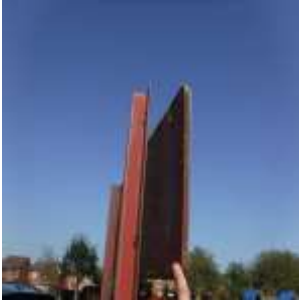
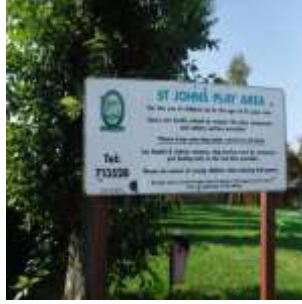
Asset Name	Finding Title	Finding Creation	Resolve By Date	Risk Level	Risk Value	Standard Ref	Cause
Signage	Fixtures - Loose or Missing - (previously reported)	21/09/2020	22/12/2020	Very Low	1 x 2 = 2		Wear and Tear

Standard Description: Fixtures loose or missing

Replace missing fasteners, fixtures and fitting

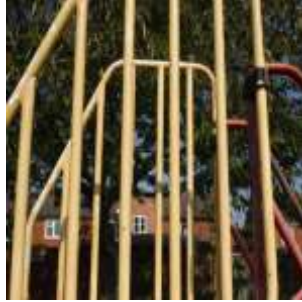
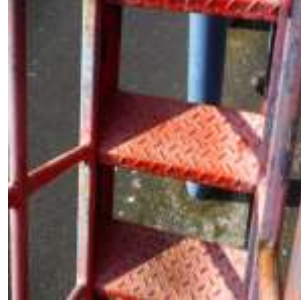
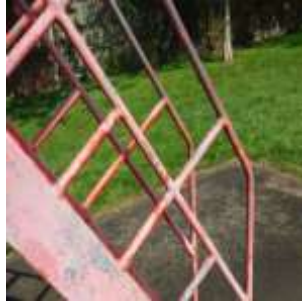
Asset Name	Finding Title	Finding Creation	Resolve By Date	Risk Level	Risk Value	Standard Ref	Cause
Slide	EN1176:2017 - Part 1 - Compliance - (previously reported)	21/09/2020	21/09/2021	Very Low	1 x 3 = 3	EN 1176:2017 - 1	Manufacturer Defect

No action required, based on risk assessment, as asset pre-dates EN 1176

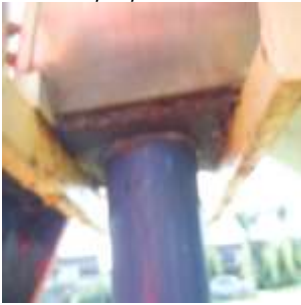
Asset Name	Finding Title	Finding Creation	Resolve By Date	Risk Level	Risk Value	Standard Ref	Cause
Slide	Metal - Excessive Corrosion - (previously reported)	21/09/2020	21/09/2021	Very Low	1 x 2 = 2		Wear and Tear

Standard Description: Metal excessive corrosion

Monitor

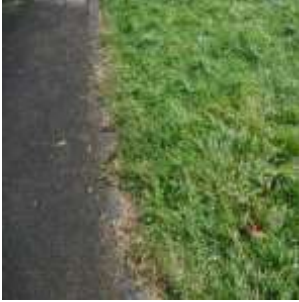
Asset Name	Finding Title	Finding Creation	Resolve By Date	Risk Level	Risk Value	Standard Ref	Cause
Slide Surface	Surface - Grass, Moss or Weeds - (previously reported)	21/09/2020	23/03/2021	Very Low	1 x 3 = 3		Routine

Remove grass, moss & weeds from playing surface

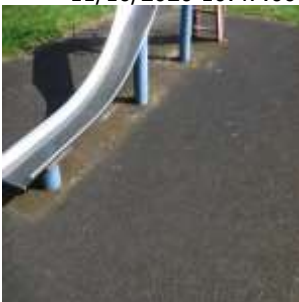
Asset Name	Finding Title	Finding Creation	Resolve By Date	Risk Level	Risk Value	Standard Ref	Cause
Slide Surface	Surface - Wearing - (previously reported)	21/09/2020	21/09/2021	Very Low	1 x 3 = 3		Wear and Tear

Standard Description: Surface wearing

Monitor

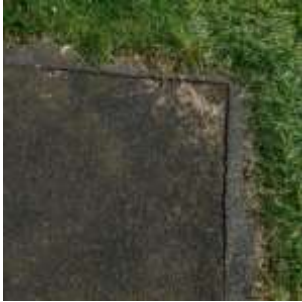
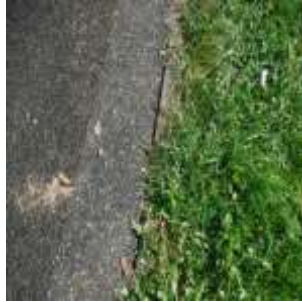
Asset Name	Finding Title	Finding Creation	Resolve By Date	Risk Level	Risk Value	Standard Ref	Cause
Slide Surface	Surface - Edges Shrunk - (previously reported)	21/09/2020	21/09/2021	Very Low	1 x 2 = 2		Wear and Tear

Monitor

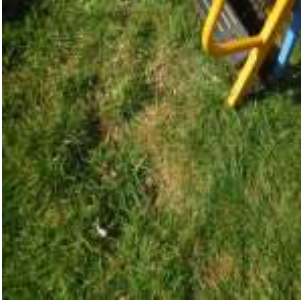
Asset Name	Finding Title	Finding Creation	Resolve By Date	Risk Level	Risk Value	Standard Ref	Cause
Toddler Multiplay Surface	Ground Eroded - (previously reported)	21/09/2020	23/03/2021	Very Low	1 x 3 = 3		Wear and Tear

Make good surface

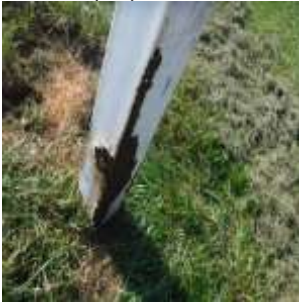
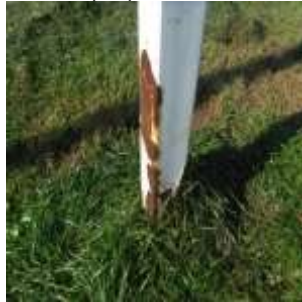
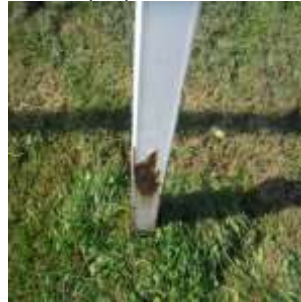
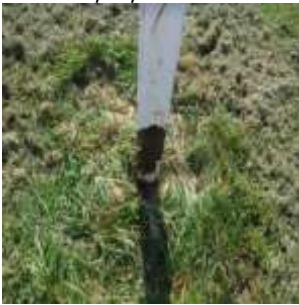
Asset Name	Finding Title	Finding Creation	Resolve By Date	Risk Level	Risk Value	Standard Ref	Cause
Goal Posts	Item - Rusting in places - (previously reported)	21/09/2020	23/03/2021	Very Low	1 x 1 = 1		Wear and Tear

Standard Description: Item is rusting in places

De-rust and coat with paint meeting EN 1176 - 4.1.1 [1998]

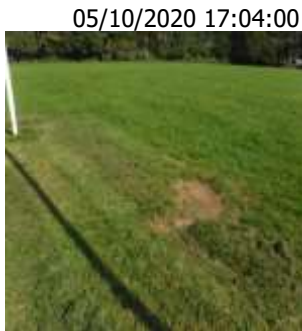
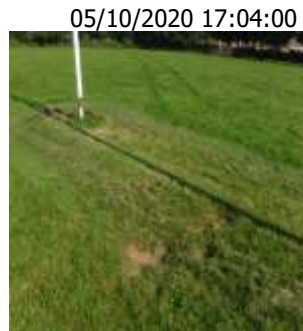
Asset Name	Finding Title	Finding Creation	Resolve By Date	Risk Level	Risk Value	Standard Ref	Cause
Goal Posts	Ground Eroded - (previously reported)	21/09/2020	23/03/2021	Very Low	1 x 2 = 2		Wear and Tear

Standard Description: Ground eroded

Task Title
Make good surface

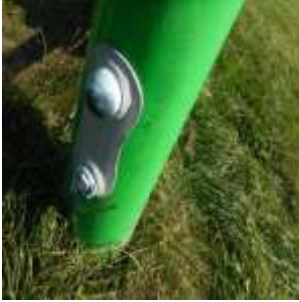
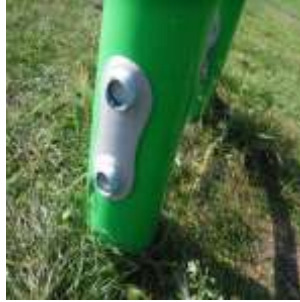
Asset Name	Finding Title	Finding Creation	Resolve By Date	Risk Level	Risk Value	Standard Ref	Cause
Gym - Activity Station	Item - Cap(s) damaged - (previously reported)	21/09/2020	23/03/2021	Very Low	1 x 1 = 1		Wear and Tear

Standard Description: Cap(s) damaged

Replace item

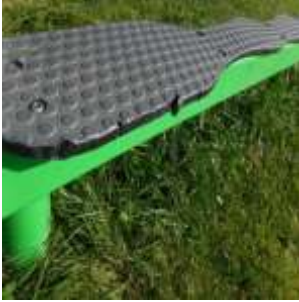
Asset Name	Finding Title	Finding Creation	Resolve By Date	Risk Level	Risk Value	Standard Ref	Cause
Gym - Balance Beam	Item - Hard or Sharp Projections - (previously reported)	21/09/2020	22/12/2020	Low	2 x 2 = 4		Wear and Tear

Remove hard, pointed & sharp projections

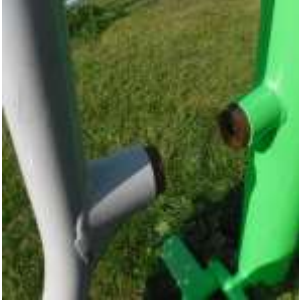
Asset Name	Finding Title	Finding Creation	Resolve By Date	Risk Level	Risk Value	Standard Ref	Cause
Gym - Leg Press	Moving Parts - End Stops (Head/Hand/Foot) - (previously reported)	21/09/2020	21/09/2021	Very Low	1 x 3 = 3	EN 16630 - 4.3.5	Manufacturer Defect

No action required, based on risk assessment, as asset pre-dates EN 16630

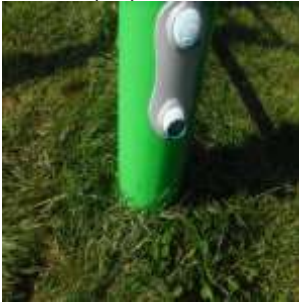
Asset Name	Finding Title	Finding Creation	Resolve By Date	Risk Level	Risk Value	Standard Ref	Cause
Gym - Overhead Ladder	Item - Cap(s) damaged - (previously reported)	21/09/2020	23/03/2021	Very Low	1 x 2 = 2		Wear and Tear

Standard Description: Cap(s) damaged

Replace item

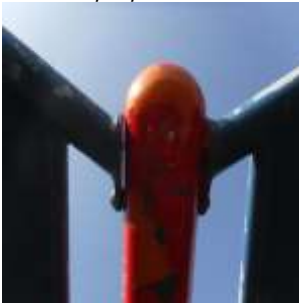
Asset Name	Finding Title	Finding Creation	Resolve By Date	Risk Level	Risk Value	Standard Ref	Cause
Shelter	Item - Parts Missing - (previously reported)	21/09/2020	23/03/2021	Very Low	1 x 1 = 1		Wear and Tear

Standard Description: Item has some parts missing

Replace missing parts

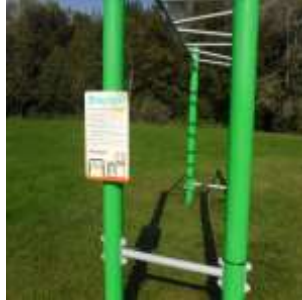
Asset Name	Finding Title	Finding Creation	Resolve By Date	Risk Level	Risk Value	Standard Ref	Cause
Sign	Item - Incorrectly Installed - (previously reported)	21/09/2020	22/12/2020	Low	3 x 3 = 9		Poor Maintenance

Repair item

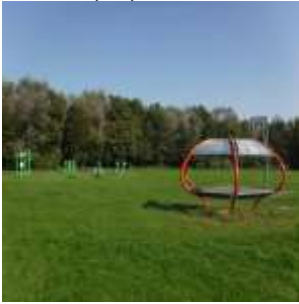
Asset Name	Finding Title	Finding Creation	Resolve By Date	Risk Level	Risk Value	Standard Ref	Cause
Site - Tudor Mead - Gym and Basketball	Information for Use - Signage - (previously reported)	21/09/2020	23/03/2021	Very Low	1 x 1 = 1	EN 16630 - 7.1	Installation Defect

Modify to meet EN 16630.

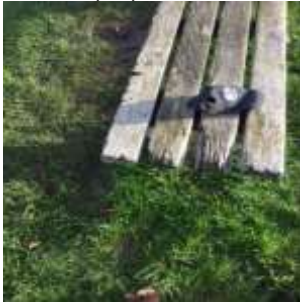
Asset Name	Finding Title	Finding Creation	Resolve By Date	Risk Level	Risk Value	Standard Ref	Cause
Bench x2	Fixtures - Loose or Missing	08/12/2020	10/03/2021	Very Low	1 x 2 = 2		Wear and Tear

Standard Description: Fixtures loose or missing

Task Notes: Bench next to bin One end of bench slat is loose

Tighten loose fixtures & fittings

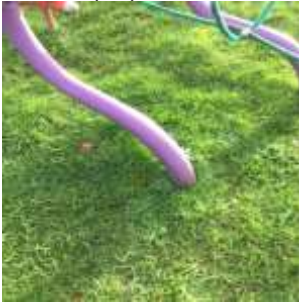
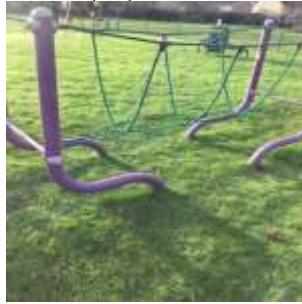
Asset Name	Finding Title	Finding Creation	Resolve By Date	Risk Level	Risk Value	Standard Ref	Cause
Trim Trail	Item - Loose in Ground	08/12/2020	10/03/2021	Very Low	1 x 2 = 2		Wear and Tear

Standard Description: Loose in ground

Monitor

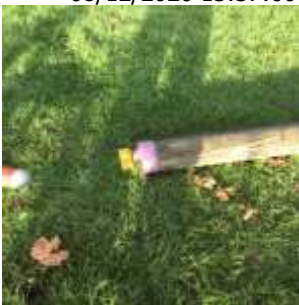
Asset Name	Finding Title	Finding Creation	Resolve By Date	Risk Level	Risk Value	Standard Ref	Cause
Trim Trail	Item - Loose in Ground	08/12/2020	09/06/2021	Very Low	1 x 2 = 2		Wear and Tear

Standard Description: Loose in ground

Monitor

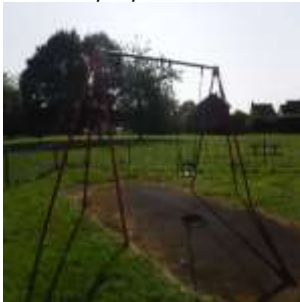
Asset Name	Finding Title	Finding Creation	Resolve By Date	Risk Level	Risk Value	Standard Ref	Cause
1 Bay 2 Cradle Seat Swing	Swing - Seats - Missing - (previously reported)	21/09/2020	23/03/2021	Very Low	1 x 1 = 1		Routine

Standard Description: Swing seats missing

No action given the risk assessment

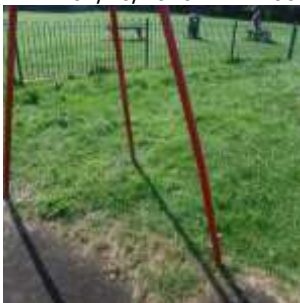
Asset Name	Finding Title	Finding Creation	Resolve By Date	Risk Level	Risk Value	Standard Ref	Cause
1 Bay 2 Cradle Seat Swing	Item - Bent - (previously reported)	21/09/2020	21/09/2021	Very Low	1 x 1 = 1		Wear and Tear

No action given the risk assessment

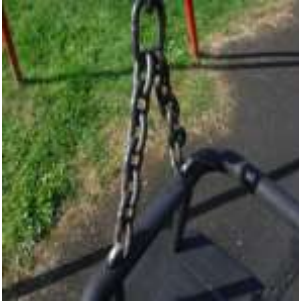
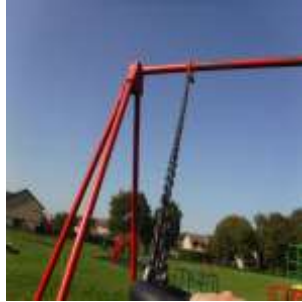
Asset Name	Finding Title	Finding Creation	Resolve By Date	Risk Level	Risk Value	Standard Ref	Cause
1 Bay 2 Cradle Seat Swing	Swing - Chains twisted - (previously reported)	21/09/2020	23/03/2021	Very Low	1 x 1 = 1		Poor Maintenance

Refit chains

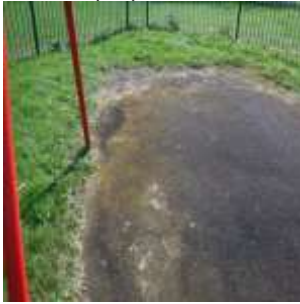
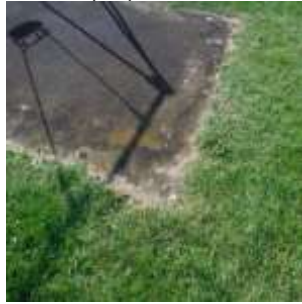
Asset Name	Finding Title	Finding Creation	Resolve By Date	Risk Level	Risk Value	Standard Ref	Cause
1 Bay 2 Cradle Seat Swing Surface	Surface - Grass, Moss or Weeds - (previously reported)	21/09/2020	23/03/2021	Very Low	1 x 3 = 3		Routine

Remove grass, moss & weeds from playing surface

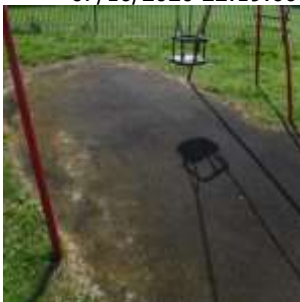
Asset Name	Finding Title	Finding Creation	Resolve By Date	Risk Level	Risk Value	Standard Ref	Cause
1 Bay 2 Cradle Seat Swing Surface	Surface - Wearing - (previously reported)	21/09/2020	21/09/2021	Very Low	1 x 2 = 2		Wear and Tear

Standard Description: Surface wearing

Monitor

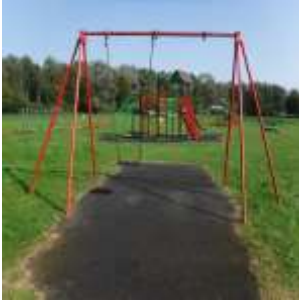
Standard Description: Swing seats missing

No action given the risk assessment

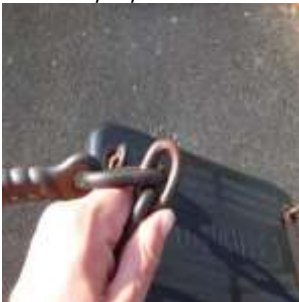
Asset Name	Finding Title	Finding Creation	Resolve By Date	Risk Level	Risk Value	Standard Ref	Cause
1 Bay 2 Flat Seat Swing	Chain - Links Worn - (previously reported)	21/09/2020	21/09/2021	Very Low	1 x 3 = 3		Wear and Tear

Task Title
Monitor

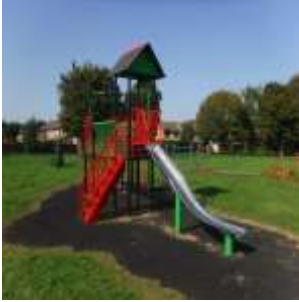
Asset Name	Finding Title	Finding Creation	Resolve By Date	Risk Level	Risk Value	Standard Ref	Cause
Junior Multiplay	Item - Cap(s) missing - (previously reported)	21/09/2020	23/03/2021	Very Low	1 x 2 = 2		Wear and Tear

Standard Description: Cap(s) missing

No action required, based on risk assessment, as asset pre-dates EN 1176
