Gordon Playground
Inspections LTD **PSSLive+**

Operational Inspection – December 2020

Churchdown Parish Council

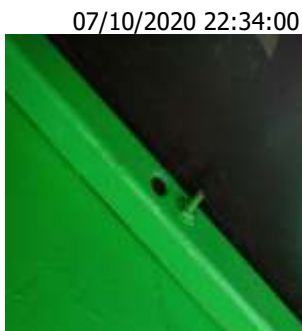
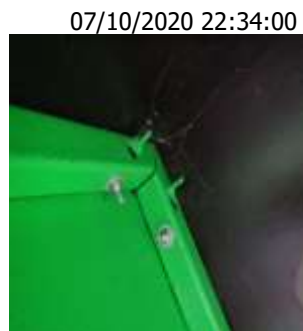
Asset Name	Finding Title	Finding Creation	Resolve By Date	Risk Level	Risk Value	Standard Ref	Cause
Junior Multiplay	Finish - Bolts Protruding - (previously reported)	21/09/2020	23/03/2021	Very Low	1 x 2 = 2	EN 1176:2017 - 1 - 4.2.5	Poor Maintenance

Standard Description: There are bolt threads protruding within the accessible parts of the equipment that are not permanently covered (e.g. dome headed nuts).

Task Title
Remove excessive threads

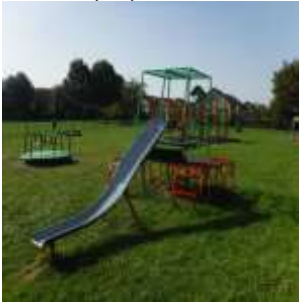
Asset Name	Finding Title	Finding Creation	Resolve By Date	Risk Level	Risk Value	Standard Ref	Cause
Junior Multiplay (Excavator)	EN1176 - Part 1 and Part 3 - Compliance - (previously reported) Edited on 07/10/2020 22:37:35	21/09/2020	21/09/2021	Very Low	1 x 3 = 3	EN 1176:2017 - 1 and EN1176:2017 - 3	Manufacturer Defect

No action required, based on risk assessment, as asset pre-dates EN 1176

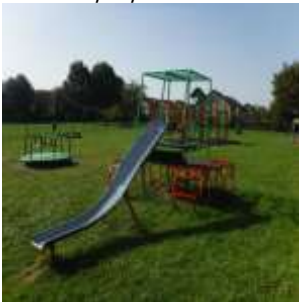
Asset Name	Finding Title	Finding Creation	Resolve By Date	Risk Level	Risk Value	Standard Ref	Cause
Junior Multiplay (Excavator)	Metal - Excessive Corrosion - (previously reported)	21/09/2020	21/09/2021	Very Low	1 x 2 = 2		Wear and Tear

Standard Description: Metal excessive corrosion

Monitor

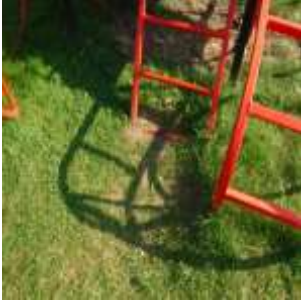
Asset Name	Finding Title	Finding Creation	Resolve By Date	Risk Level	Risk Value	Standard Ref	Cause
Junior Multiplay (Excavator) Surface	Ground Eroded - (previously reported)	21/09/2020	23/03/2021	Very Low	1 x 3 = 3		Wear and Tear

Make good surface

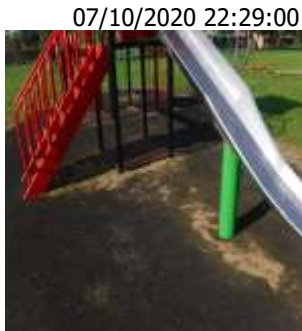
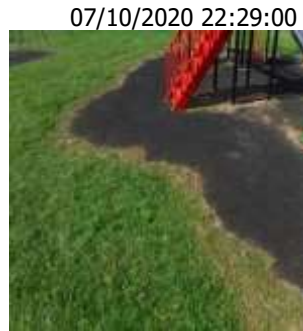
Asset Name	Finding Title	Finding Creation	Resolve By Date	Risk Level	Risk Value	Standard Ref	Cause
Junior Multiplay Surface	Surface - Grass, Moss or Weeds - (previously reported)	21/09/2020	23/03/2021	Very Low	1 x 3 = 3		Routine

Standard Description: Surface has unintended grass, moss or weeds

Remove grass, moss & weeds from playing surface

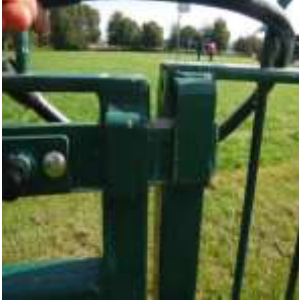
Asset Name	Finding Title	Finding Creation	Resolve By Date	Risk Level	Risk Value	Standard Ref	Cause
Maintenance Gate	Item - Repair/s - Minor - (previously reported)	21/09/2020	23/03/2021	Very Low	1 x 2 = 2		Wear and Tear

Standard Description: Item needs minor repair/s

Repair item

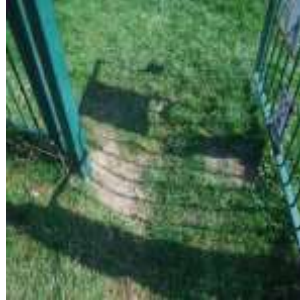
Asset Name	Finding Title	Finding Creation	Resolve By Date	Risk Level	Risk Value	Standard Ref	Cause
Pedestrian Gate x2	Ground Eroded - (previously reported)	21/09/2020	23/03/2021	Very Low	1 x 3 = 3		Wear and Tear

Make good surface

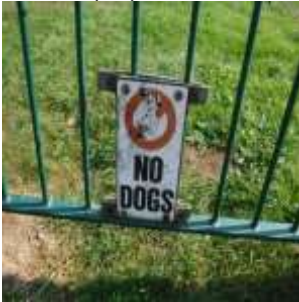
Asset Name	Finding Title	Finding Creation	Resolve By Date	Risk Level	Risk Value	Standard Ref	Cause
Signage	Sign - Incorrect height - (previously reported)	21/09/2020	23/03/2021	Very Low	1 x 1 = 1		Wear and Tear

Adjust height of sign

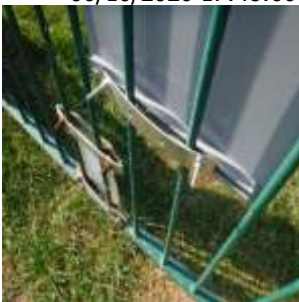
Asset Name	Finding Title	Finding Creation	Resolve By Date	Risk Level	Risk Value	Standard Ref	Cause
Signage	Finish - Bolts Protruding - (previously reported)	21/09/2020	22/12/2020	Low	2 x 2 = 4	EN 1176:2017 - 1 - 4.2.5	Installation Defect

Remove excessive threads

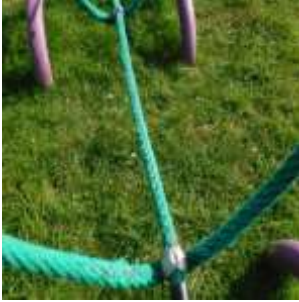
Asset Name	Finding Title	Finding Creation	Resolve By Date	Risk Level	Risk Value	Standard Ref	Cause
Trim Trail	Rope - Metal core exposed - (previously reported)	21/09/2020	21/09/2021	Very Low	1 x 1 = 1		Wear and Tear

Monitor
